INCIDENT ALERT

LOCATION:	COMPANY-WIDE	ALERT STATUS:	Normal
ACTIVITY:	MAINTENANCE & HOUSEKEEPING	DATE ISSUED:	31/05/2016 12:13:15
SUB ACTIVITY:	N/A	INCIDENT No:	01432

Tyre fitter trapped under foam filled tyre

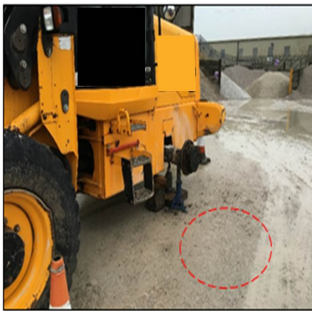
A contract tyre fitter (IP) working on a hired loading shovel suffered bruising to his right arm and left leg after becoming trapped beneath a foam filled tyre and wheel assembly, when the tyre fell onto him after he unbolted the wheel in preparation for changing the tyre - see Photograph 1.

- The loading shovel was on hire and neither the Company nor the tyre fitter knew the tyre was foam filled.
- The IP assumed it was a punctured air-filled tyre because it had deflated (the foam inside the tyre had deteriorated giving the appearance of a punctured pneumatic tyre – foam tyres don't normally deflate).
- The foam filled tyre weighed in excess of 400kg (two or three times heavier than an air filled tyre). It took two people to lift the tyre off the trapped fitter.
