## Significant Incident Report No. 241

**Subject:** Underground worker crushed between integrated tool carrier (IT) work basket and roof of excavation (backs)

**Date:** 07 June 2016

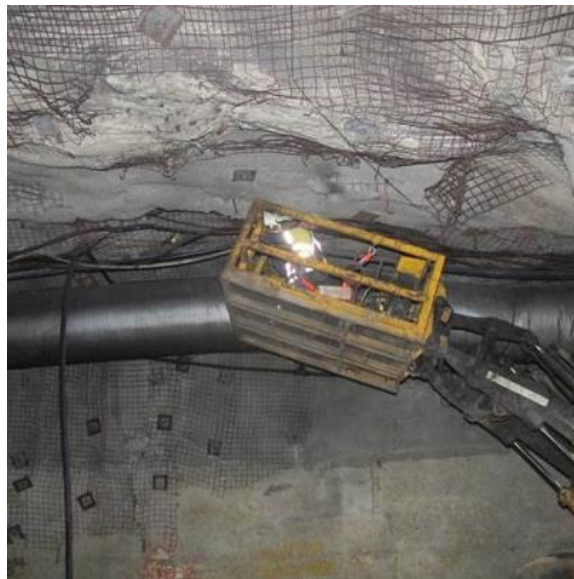
In March 2016, two servicemen were working in an integrated tool carrier (IT) work basket removing pipe services from the sidewall and backs of an extra-high excavation. At the time of the incident, the work basket had been raised close to the backs but extra lift was needed and the basket was tilted upwards. A worker who was leaning over the front of the basket received serious head injuries when crushed between the top rail of the basket and the backs.

IT work basket in position beneath the backs

The worker was leaning over the front of the basket when the basket was tilted upwards.

- Lack of effective communication between personnel.
- The injured person was new to the task and was undergoing training.

- Tilting of the work basket was not included in the training documentation.
- The operator directing the work basket was not aware of the position of the offside when the direction was given to tilt the work basket.
- The operating procedure did not identify the potential for a crush hazard while conducting work from the basket.

- When undertaking work at height using IT or EWP work baskets, identify and address the potential for workers to be crushed between the basket and adjacent structures. Work should be done without leaning over the edge of the work basket.
- Confirm that the equipment is fit-for-purpose — tilting the work basket for extra reach height introduces additional hazards from sloping floor surfaces.
- Consider installing height-limiting sensors or physical barriers to prevent crush nip points for personnel working in work baskets.
- Consider installing audible movement warning buzzers to work baskets.

- Implement and promote positive communication protocols between all personnel involved in the work to maintain situational awareness. This may include verbal and visible means of communications.
- Develop and implement standard signals for the control of IT and EWP work baskets.

- Provide employees with adequate instruction, training, assessment and supervision to conduct work safely from IT and EWP work baskets.
- Include guidance on the signals for controlling work baskets in training packages.
