INCIDENT ALERT

ALERT STATUS: Normal
DATE ISSUED: 21/04/2016 13:23:27
INCIDENT No: 01428

Equipment mounted at height

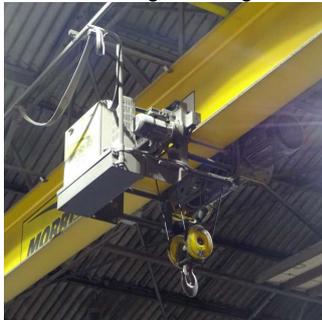
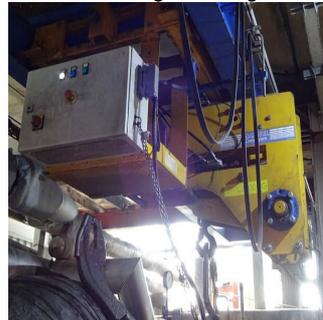
This alert is issued following a previous alert regarding the failure of a drive motor and gearbox mounted at height.

- Ensure Planned Preventive Maintenance (PPM) is scheduled in line with manufacturer's recommendations as a minimum
- In harsher environments and high usage, more frequent inspection may be required.

- Ensure all materials used in the PPM or breakdown repairs meet with the manufacturer's specification, and any other technical standards that may apply.

- Where individual component parts require replacing consider the benefit of replacing the whole assembly to avoid the potential for backlash.
- Carry out assessments identifying areas where equipment is mounted / travels over people, consider fitting a secondary securing device.

- Secondary securing devices prevent a component falling from height if the primary securing method fails. This could be a safety wire or some other engineered method designed for this function. Secondary securing devices should be sufficient to withstand the shock loading that may occur if the primary securing method fails.

- Encourage employees to maintain vigilance and report concerns with machinery (for example: report strange noises / changes in operating performance as potential hazards).
