MINE SAFETY INVESTIGATION UNIT

INFORMATION RELEASE

Event Collision between front-end loader and light vehicle

Location Whitehaven Coal Handling Preparation Plant, Gunnedah NSW

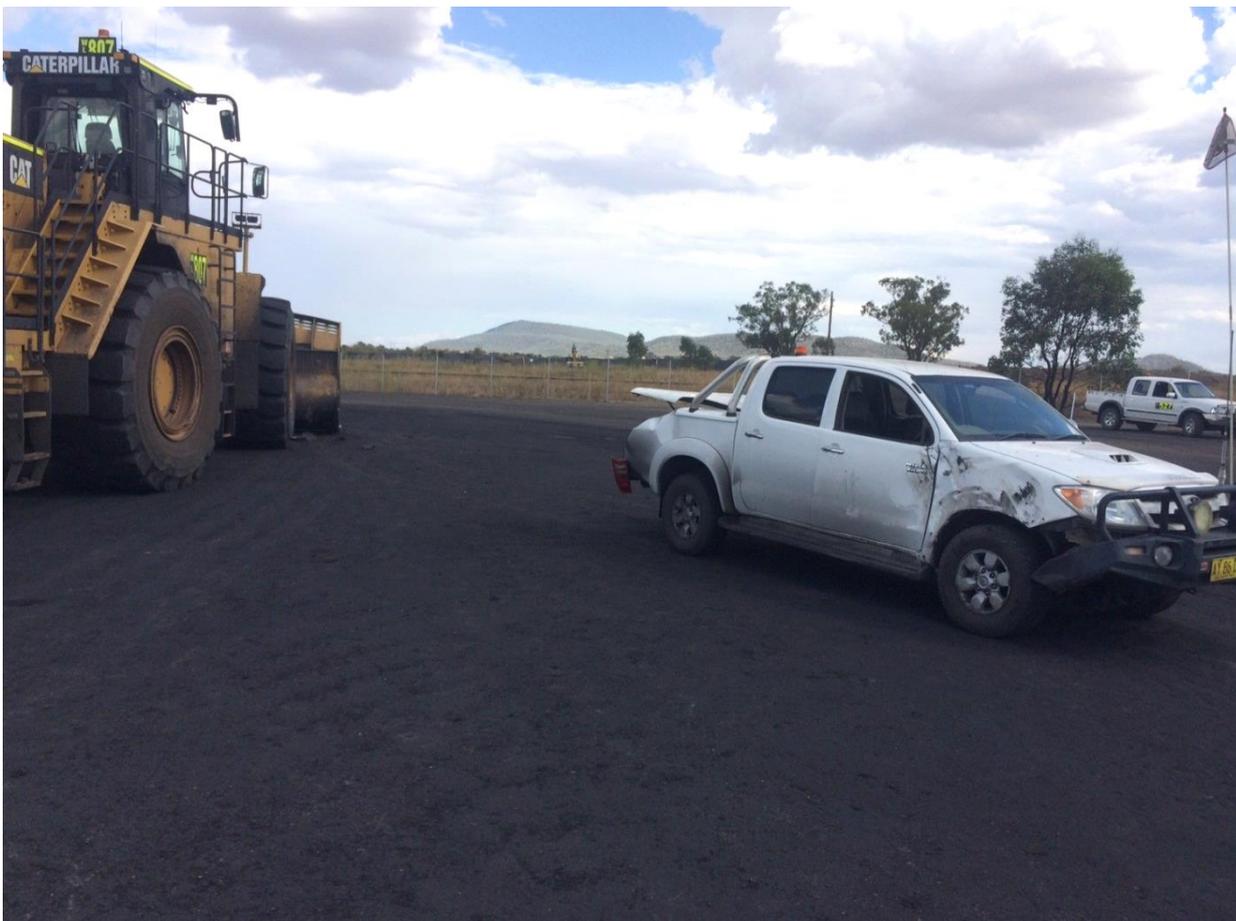
Photograph taken by the mine of the damaged light vehicle and the loader involved in the incident.

The loader's right front wheel skimmed the light vehicle near the driver's door and the loader bucket impacted the rear of the light vehicle before it stopped. The light vehicle operator then drove the damaged vehicle away from the loader.
