# Articulated truck rollovers

Mines safety bulletin no. 170

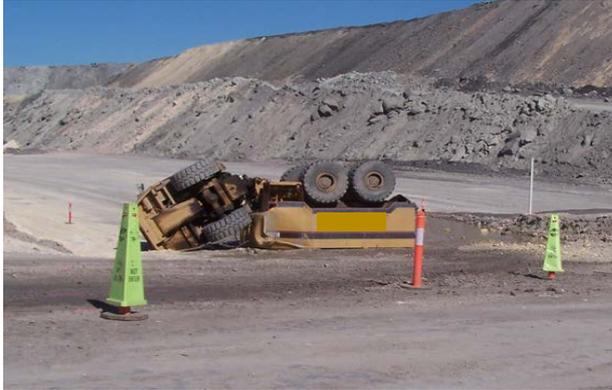
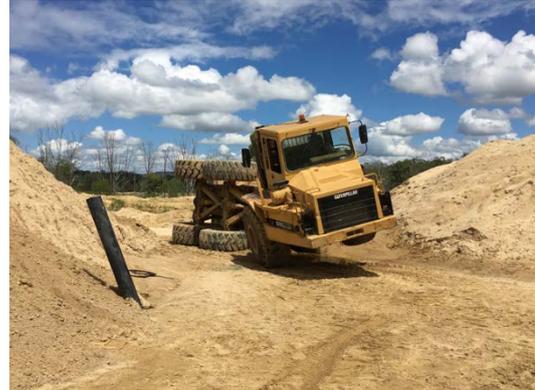
On average, an articulated dump truck / water truck rollover occurs every 2 months and of the 64 incidents reported since 2006:

- 37% occurred whilst vehicles were reversing—riding up over uneven ground or stockpiles.
- 35% occurred whilst vehicles were turning—speed, downhill, reverse cambers and wet surfaces.
- 22% occurred whilst vehicles were travelling—operator loss of control.
- 6% occurred on sloping ground.

Fortunately, these vehicles are designed so that the cabin has remained upright in most (92%) rollover incidents. Despite this, workers have sustained injuries (some serious) in 6% of these incidents.

The continuation of these rollover events at quarries and mines is evidence that the risk controls for operating articulated trucks are both inadequate and ineffective at an industry level.

Site senior executives are expected to develop (or review) risk assessments specific to **the operation of articulated vehicles** where they are utilised, and implement and maintain effective controls identified and agreed to during the risk assessment process.

Such risk assessments should consider the following factors as a minimum:

- Requirements for training and competency of operators, and supervisors
- Mandatory wearing of seat belts
- Roadway and circuit design criteria, such as curves, cambers, road surface, watering procedures
- Operational limitations eg speed restrictions, maximum grades/ slopes etc
- Dump area design and dump procedures.
