Week ending 11 April 2018

This incident summary provides information on reportable incidents and safety advice for the NSW mining industry. To report an incident to the NSW Resources Regulator: phone 1300 814 609 24 hours a day, 7 days a week.

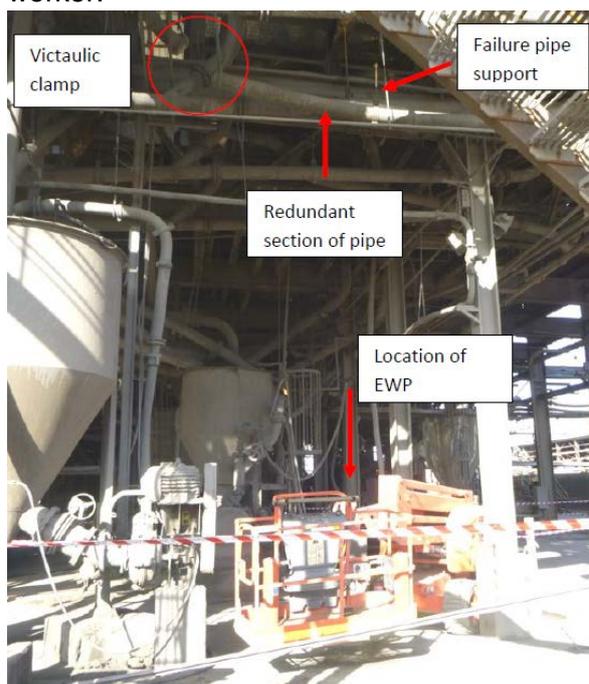
Serious injury
SinNot-2018/00520

A worker suffered crush injuries and bruising to his arm when he was removing pipework in an elevated work platform (EWP). The pipe he was undoing suddenly released and fell, hitting his arm against the handrail. A second EWP was required to recover the pipe and release the worker.

Risk assessments for operation of EWPs should consider the risks associated with a requirement to retrieve or rescue workers from heights.

Procedures must be in place, and suitable equipment must be available to facilitate rescue or recovery during working at heights tasks.

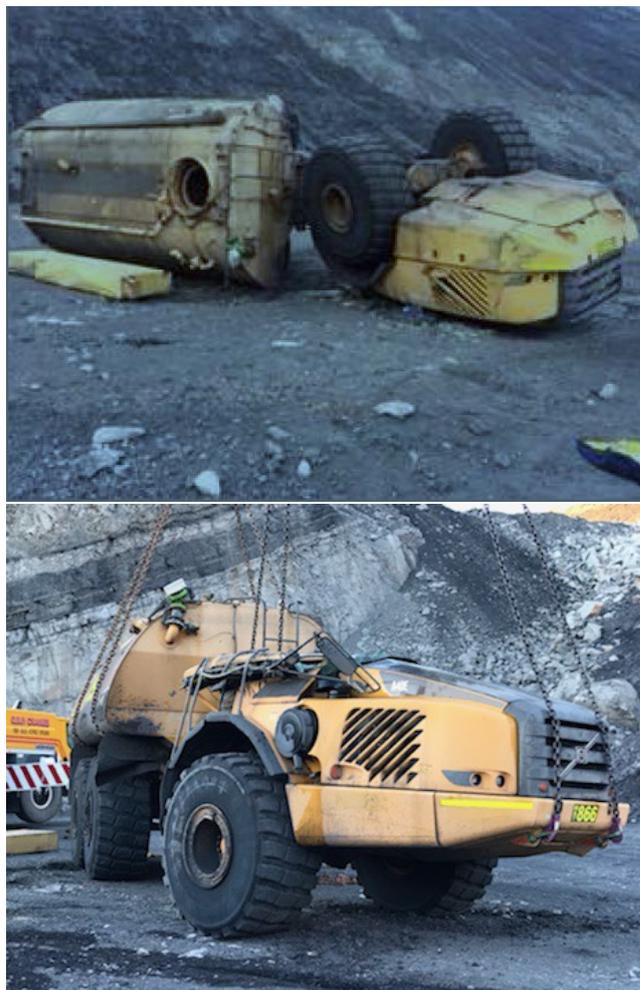
Dangerous incident
SinNot-2018/00519

A loaded articulated water cart was travelling down a ramp when it began a right-hand turn and lost control and overturned. The operator's cabin was significantly damaged, trapping the operator for some time until he was able to release himself from the vehicle.

This incident is the subject of a major investigation. The Resources Regulator will be undertaking a campaign targeting the safe operation of articulated trucks in mines, with a zero tolerance approach to machine defects, non-compliant access systems, and less than adequate operator training systems. Mine operators should review the effectiveness of controls identified within their safety management systems to manage risks associated with articulated trucks.

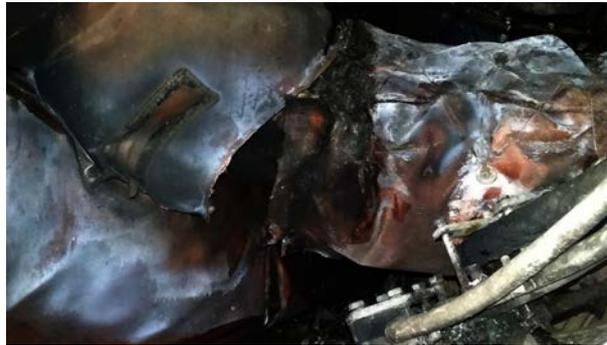
Dangerous incident
SinNot-2018/00518

A haul truck driver was alerted by a dozer driver that there was a fire visible on the truck. The truck driver stopped, applied the emergency stop and activated the fire suppression system. A hydraulic hose failed spraying oil onto the exhaust system. The fire was localised to an area where a gap in the lagging was identified.

Where lagging is used as a control, gaps, joins and transition points must be assessed for adequacy.

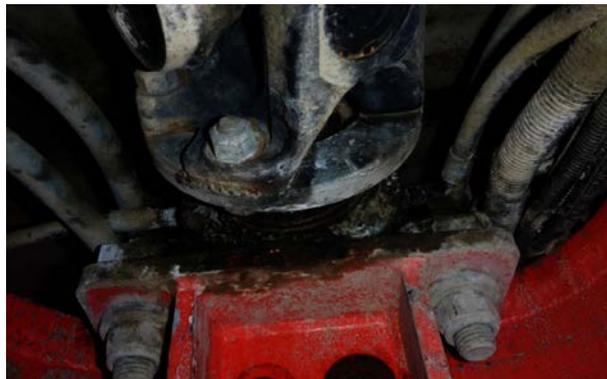
Dangerous incident
SinNot-2018/00513

Two haul trucks were passing each other when one operator noticed a flame underneath the other truck. He notified the operator and immediately parked up. The fire was extinguished using a hand-held extinguisher. The centre tail shaft bearing had failed and the heat generated ignited combustible components.

The lifecycle of components should be managed to minimise the likelihood of failures that could initiate a fire.

The Resources Regulator will be initiating a program in open cut mines in the near future examining the impacts of sub-standard maintenance practices on fires on mobile plant.

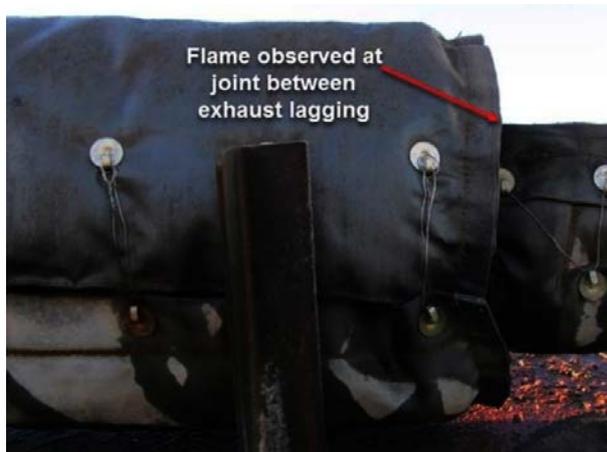
Dangerous incident
SinNot-2018/00510

A surface drill was operating when a small fire occurred. The fire was controlled using a hand-held extinguisher. An investigation identified two hydraulic hoses had rubbed through, releasing hydraulic oil that was atomised and drawn by the fan over the engine. The oil was ignited after making contact with a hot surface at a gap in the lagging near the turbo.

Hose rubbing is a known cause of failure. Mines should enforce the importance of identifying and correcting rub points during maintenance.
