REPORT OF INVESTIGATION

Fatal Powered Haulage Accident
September 11, 2018

Kocjancic
Rosebud Mining Company
Brockway, Jefferson County, Pennsylvania
ID No. 36-09436

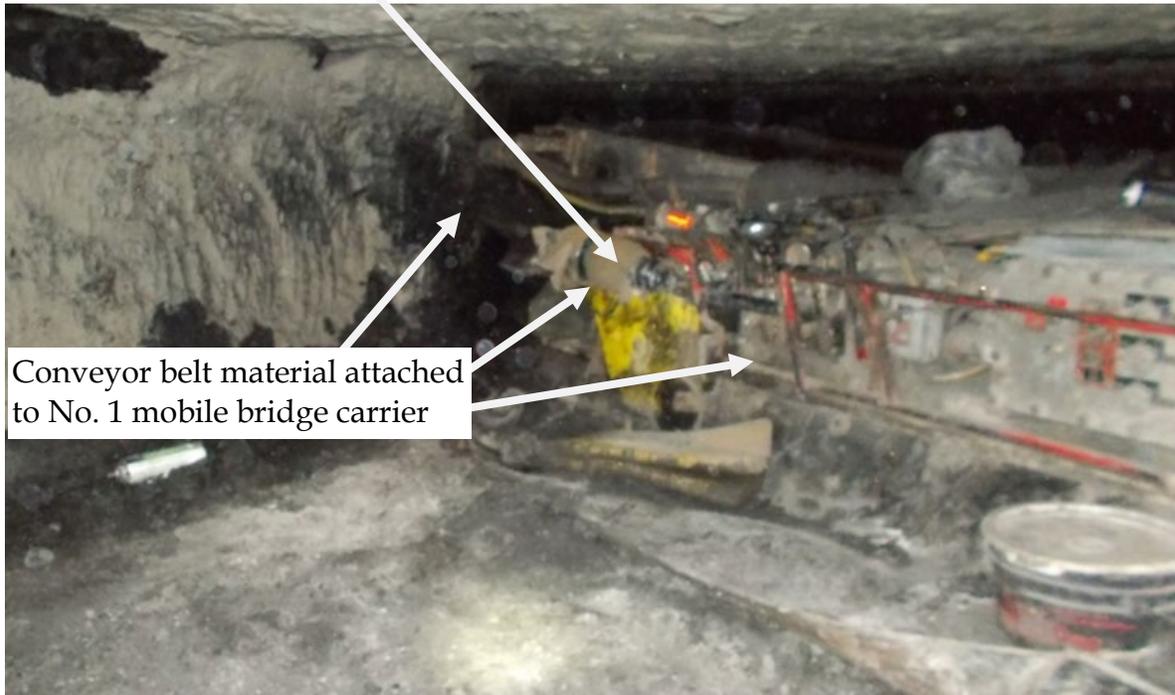
No. 1 mobile bridge carrier

Victim Location

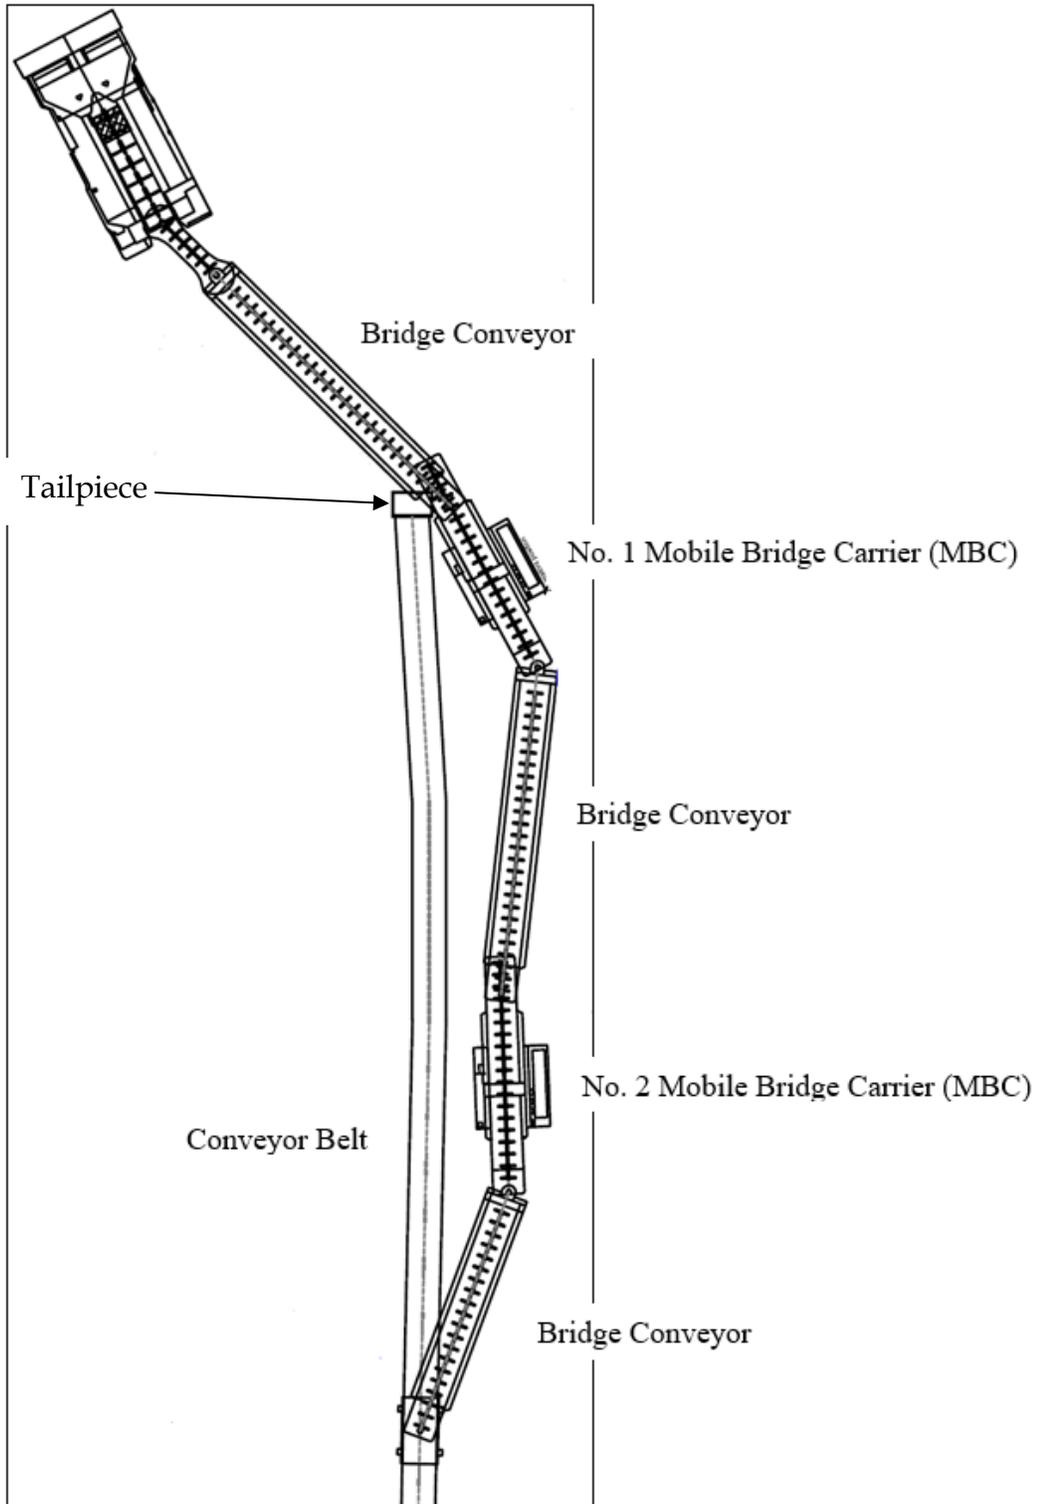
Appendix A
Continuous Haulage Mining System

The continuous haulage mining system involved in the accident is an "attached system," meaning that the MBCs and bridge conveyors are physically attached to the CMM, forming a train (see Appendix A). The train consists of one CMM, two MBCs, and three bridge conveyors. The MBCs are controlled by equipment operators who start and stop the bridge conveyors as needed.

An Eimco continuous mining machine (CMM), model number 25M-0, was connected to the first bridge conveyor, which was connected to the No. 1 Long Airdox MBC, model number MBC-27CL.

Next, the No. 1 MBC, operated by Rankin, was connected to the second bridge conveyor, which was connected to the (outby) No. 2 Long Airdox MBC, model No. 27CL, which was operated by Cary. The No. 2 MBC, in turn, was connected to the final bridge conveyor. As previously explained, mined coal was transported from the CMM, across the MBCs and bridge conveyors and dumped onto the section conveyor belt, which was connected to the main belt conveyor system, which carried the mined material to the surface.

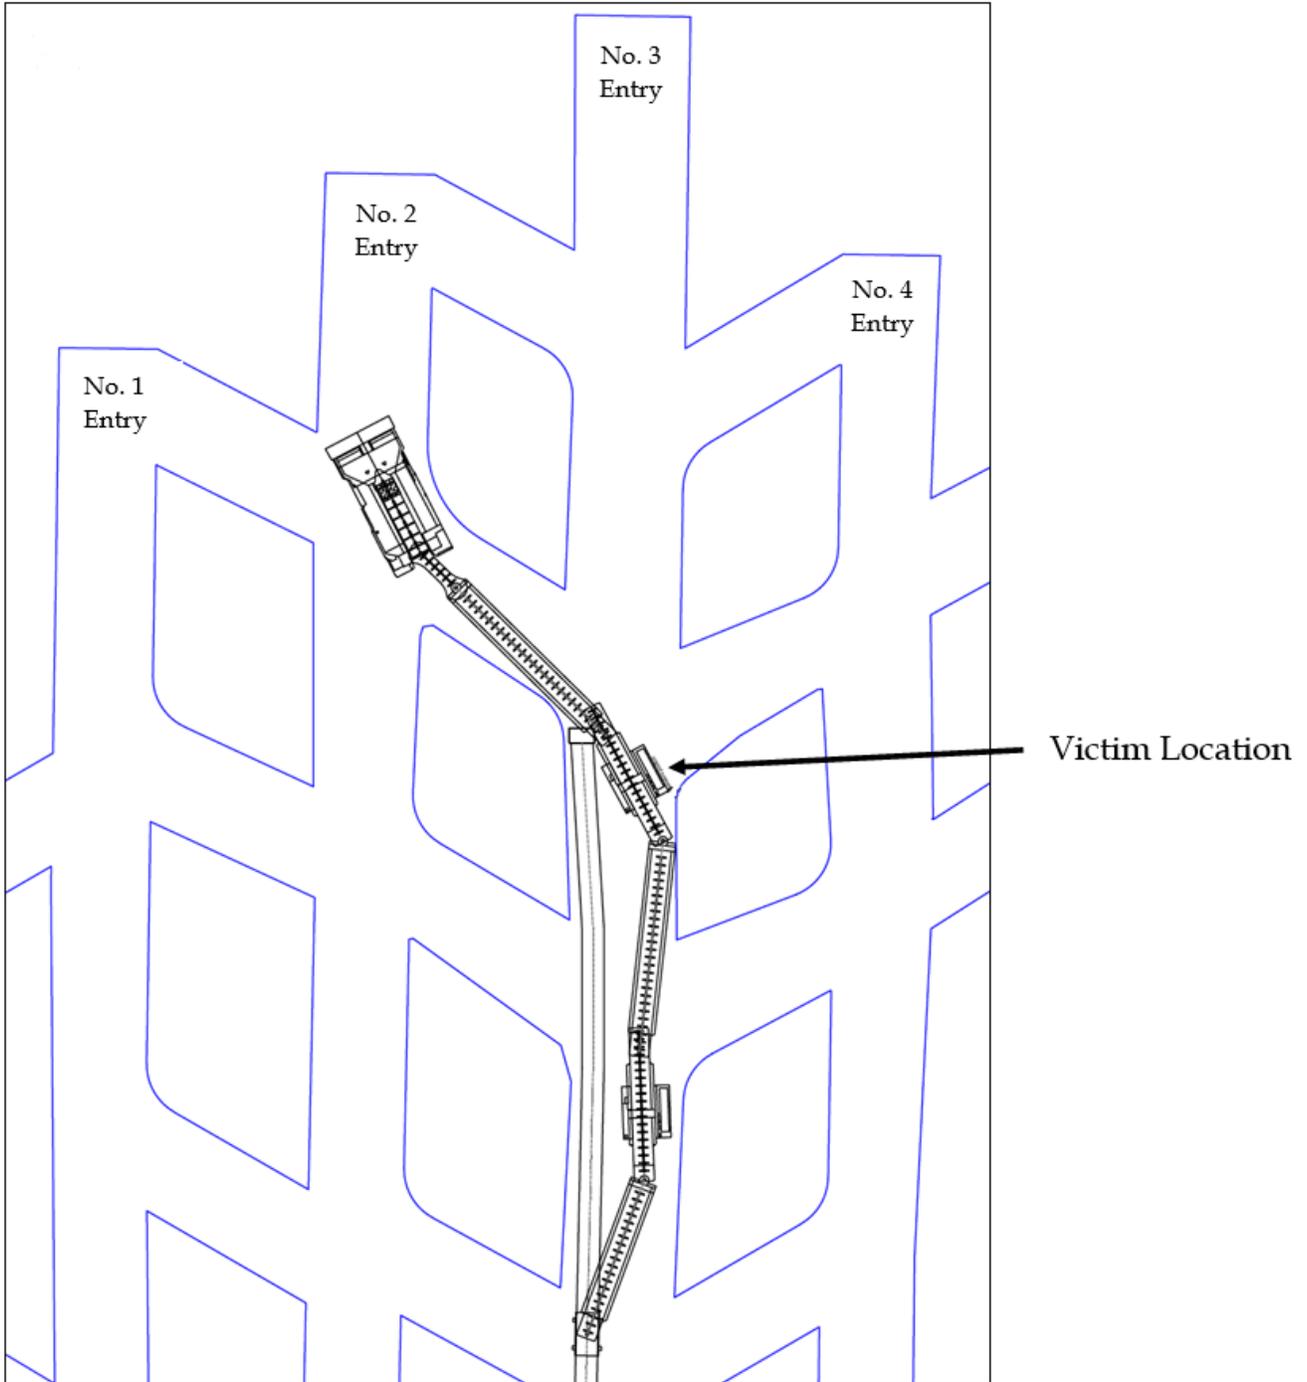
Appendix B
Victim Location
(Not to Scale)

The accident occurred in the No. 3 entry intersection of the C-8 Butt Rooms Section. The CMM backed up across the No. 2 entry intersection to allow the single-boom roof bolter to pass by into the No. 1 entry. This action placed the No. 1 MBC (victim's MBC) just outby the intersection of the No. 3 entry, alongside the stationary conveyor belt. The No. 1 MBC was idle indicating that the victim was not tramming it at the time of the accident. The CMM, while it was trammed backward, then forward, pinched the victim between the MBC and the coal rib (see Appendix B). The victim was moved along the rib line for approximately 8 feet until the MBC

reached the right outby corner of the intersection in No. 3 entry. The mined height at the victim's location is 46 inches. The mine floor was dry.
