Safety ALERT!

Fire caused second degree burns to hand from re-fueling pump

7th February 2019

0010

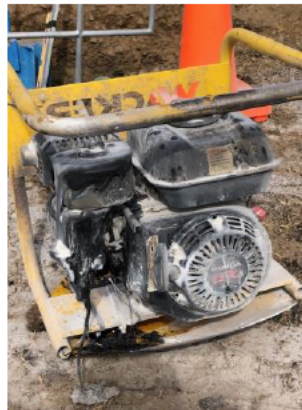
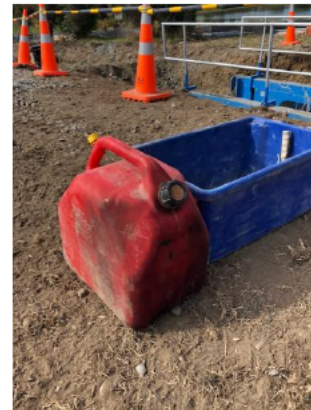
A worker was using a 20 litre fuel container to refuel a 2-inch flexi drive dewatering pump. During the procedure, petrol splashed onto the worker's hand, the lower sleeve of his work shirt and on to the hot exhaust causing the fuel to ignite. This resulted in his shirt sleeve catching fire and his hand being burnt.

- The pump had been running for approximately 4 hours before the incident occurred and the engine had been turned off immediately prior to the refueling taking place
- A pouring spout was used on the petrol container during refueling

- The hot engine exhaust had produced radiant heat as an ignition source
- The 20L petrol container was full making it difficult to direct fuel into the tank
- The work shirt being worn by the injured person caught fire and partially melted
- The risk was not identified and therefore not considered or controlled

- A small petrol container (10 Litre) has been purchased and is now being used
- Leather gloves have been provided and are used while refueling
- The risks associated with re-fueling have now been identified on the site risk register
- Fill fuel tanks slowly to avoid overflow and spillages
- Shut down engine and allow the equipment to cool down (approx. 5-10 minutes)
- Re-assess the method of de-watering where possible and consider using diesel pumps
