NZ Safety Alert

May 2019

Fly rock incident

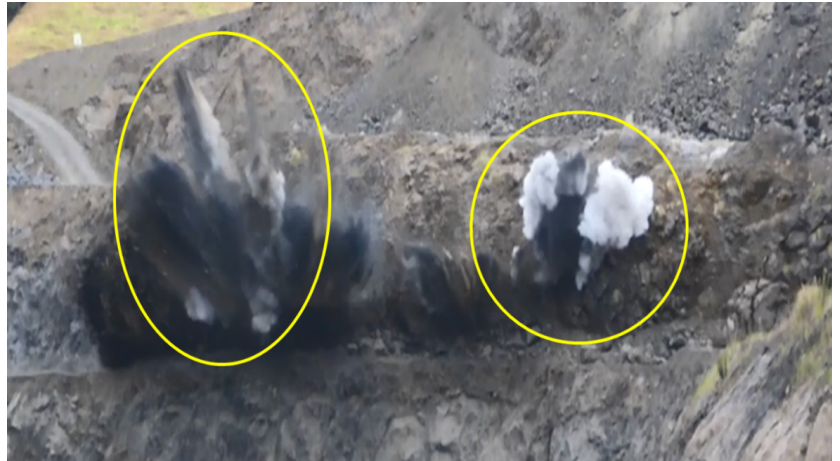
During a blast, fly rock was ejected approximately 300m, beyond the exclusion zone, and into an area where personnel were thought to be in the safe zone.

The blast was in an area of the quarry that had not been blasted for several years and it was prepared using proven design parameters previously used at the quarry. This included an exclusion zone of 80m, which was calculated from the design burden.

The contributing factors causing this incident were:

- change in geology (fractured and softer ground)
- potential drill deviation of some front face holes, resulting in a reduced burden.

1. Blast exclusion zones are calculated for each shot taking into consideration minimum safe distances for plant and people and based on actual burdens.
2. Consideration is given to laser profiling of faces and bore tracking of the front row of holes, in order to establish accuracy of drilling and actual burdens prior to loading a shot.
3. You have sufficient knowledge of your site's geology to help inform blast design and calculation of relevant safe exclusion zones.
4. You maintain regular communication with your shotfirer throughout the drill and blast process to ensure the process is conducted safely.
