Injury during jaw cleaning

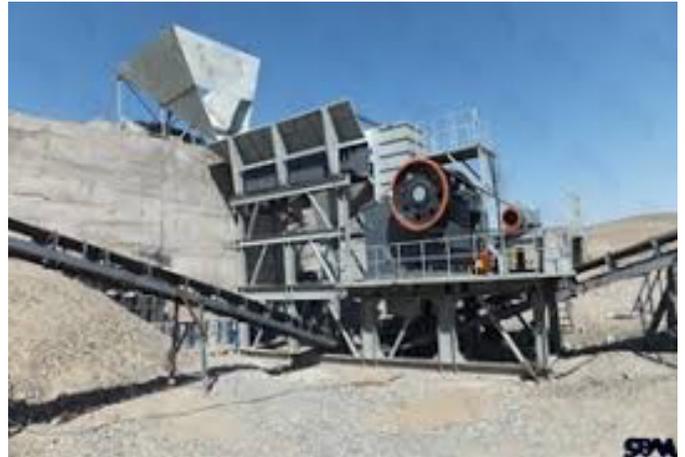
While workers were cleaning rocks from a jaw crusher, a steel plate was used as a working platform at the bottom of the jaw to ensure safe footing for workers. As workers were placing rock onto the screen (which was spring-loaded), it pushed down against the steel plate. When the steel plate was removed it tilted under the weight from the screen and the nearby supervisor reacted by trying to stabilise it. The sudden movement resulted in the supervisor receiving a torn bicep tendon injury.

The steel plate was an innovation for the site and had not been used before. Workers and management failed to identify the hazards of a new piece of plant prior to use.

1. Risk assessments are conducted before any new plant is installed or new or changed task is undertaken to identify potential hazards.
2. Where possible, blocks or other devices are used to prevent tension on plant during maintenance (in this case blocks could have been used to prevent tension on the screen).
3. Appropriate lifting lugs are installed on items being lifted to ensure an even lift (in this case lifting lugs on the steel plate may have avoided the injury).
4. Risk controls are regularly reviewed to ensure they are effective and whether additional hazards may have been created as a result controls implemented.
