DANGEROUS INCIDENT

Fuel service truck catches fire at coal mine

Incident date: 24 November 2018

Location: Maules Creek Coal Mine, Boggabri, NSW

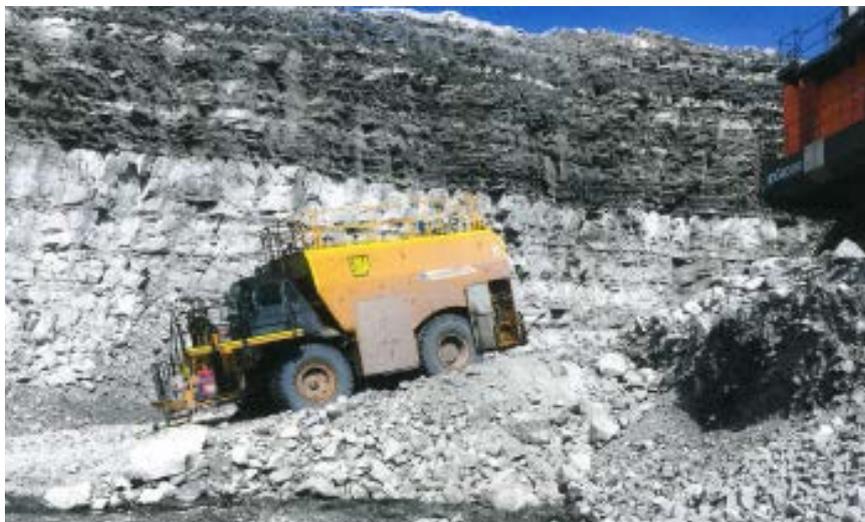
A fuel service truck caught fire at an open cut coal mine. Onboard fire suppression systems on the truck were unable to extinguish the flames because of diesel fuel flowing from the diesel tank breather vent system on the top of the fuel tank onto an ignition source. The vehicle operator escaped from the truck without injury.

Several water carts were brought in to extinguish the fire. Diesel was seen to continue to flow from the front diesel tank breather vent after the fire had been extinguished.

Figure 1: View of the fuel service truck on the ramp after the fire. Photograph courtesy of the mine.

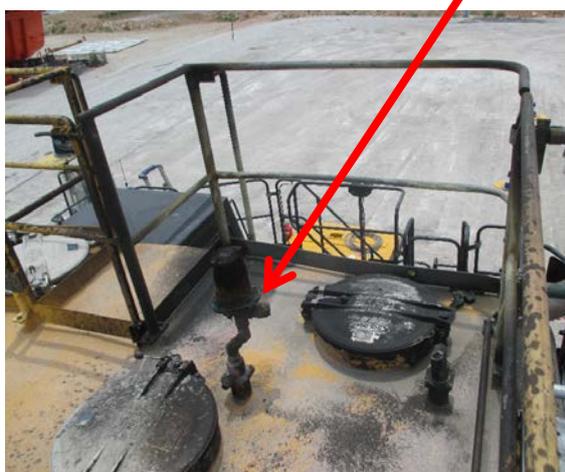
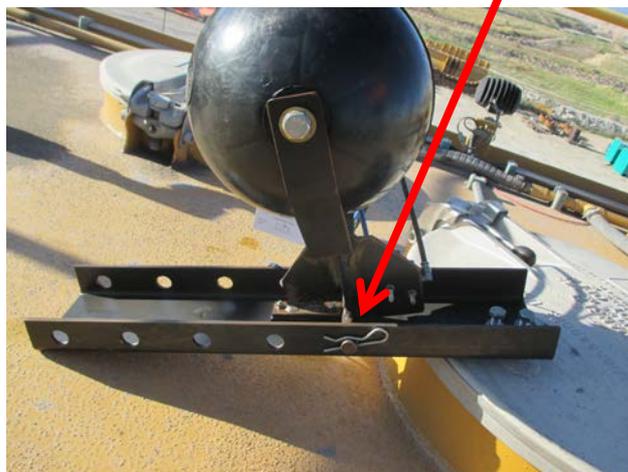
- the diesel tank's ball float valve was raised on the support bracket to a position above the original equipment manufacturer's (OEM) specifications to increase the capacity of the diesel tank to 33,400 litres (OEM calculated)
- the breather vent system was designed to allow air to vent in and out from the diesel tank during filling and discharge. The truck rollover anti-discharge valve was not designed to shut off the flow

Figure 2: View of burnt breather vent and the setting of the diesel ball float valve in the support bracket.

- the full fuel tank, in conjunction with the ramp gradient estimated at 11.9° (mine survey), caused diesel to flow from the tank breather vent and on to hot engine components

- design arrangements of the ball float and breather vent settings on fuel service trucks to ensure that they meet OEM specifications
- maintenance practices of ball float and breather vent settings on fuel service trucks to ensure life cycle inspections and maintenance programs are effectively performed
- the principal hazard management plan (fire and explosion) and mechanical engineering control plan risk assessments for fuel service trucks to ensure control measures are effective to contain and redirect flammable liquids spilled from the top of the tank away from hot surfaces
- operating gradients of fuel service trucks to ensure they are within OEM design specifications
- change management systems to ensure any modifications of fuel storage and delivery systems on fuel service trucks are appropriately assessed and include consultation with the OEM.

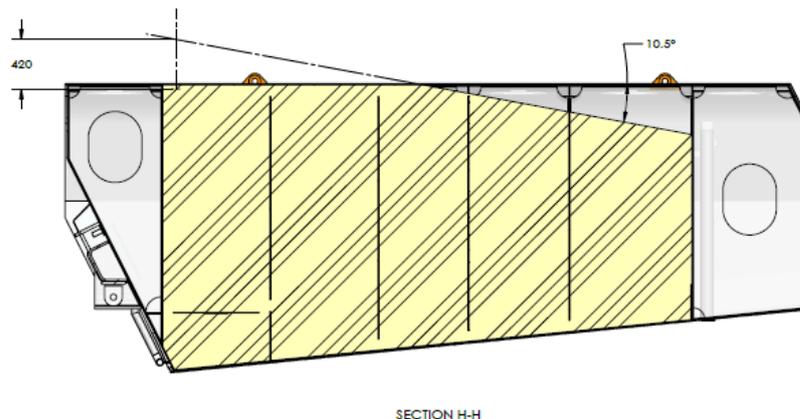
- there were no effective control measures to either contain and/or redirect the diesel spilling from either the breather vent or tank lid away from ignition sources
- when the truck was filled to the maximum of 33,400 litres the angle of inclination for fuel to run out through the breather vent (420 mm above tank) is 10.5° (OEM calculated).

Figure 3: Side view of the tank at inclination of 10.5° at 33,400 litres to cause fuel to flow through the breather vent (OEM supplied drawing).
