# WEEKLY INCIDENT SUMMARY

Week ending Friday 12 July 2019

<b>CM9 reference</b>	DOC19/610473
<b>Mine safety reference</b>	ISR19-27
<b>Date published</b>	19 July 2019
<b>Approved by</b>	Chief Inspector Office of the Chief Inspector

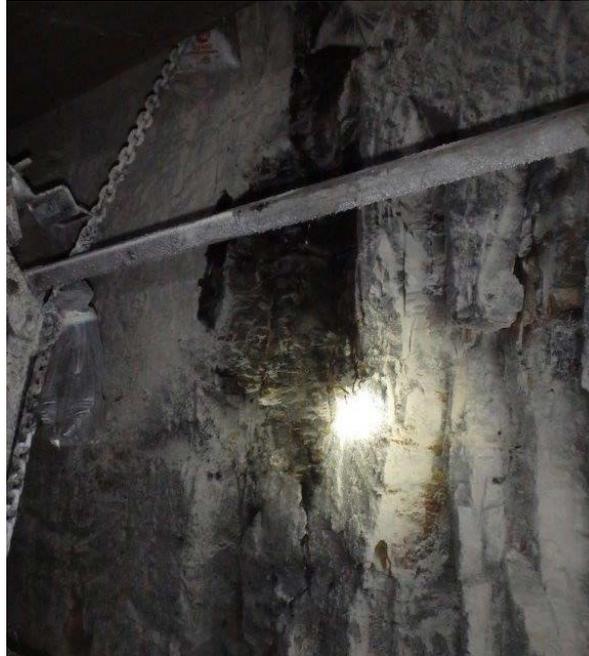
INCIDENT TYPE	SUMMARY	RECOMMENDATIONS TO INDUSTRY
Dangerous incident IncNot0035040	<p>A worker in an underground coal mine was installing 1.8 metre roof bolts (as infill secondary support) using a hand-held bolter on the narrow walkside of a conveyor belt.</p> <p>In the process of relocating the bolter to the next bolt location, it hit the rib side, causing a block of material to dislodge, which hit the worker across the shoulders, back and right leg. The block was about 1.8 metres long and 600 millimetres wide, starting from near roof level (about 1.2 metres above the worker).</p> <p>The worker was knocked to the ground and winded. After co-workers checked him for</p>	<p>The risk of strata failure should always be considered, with appropriate controls identified and implemented before work is undertaken in such locations.</p>

injuries, he was transported to the surface for treatment, where he was cleared of any significant injury.

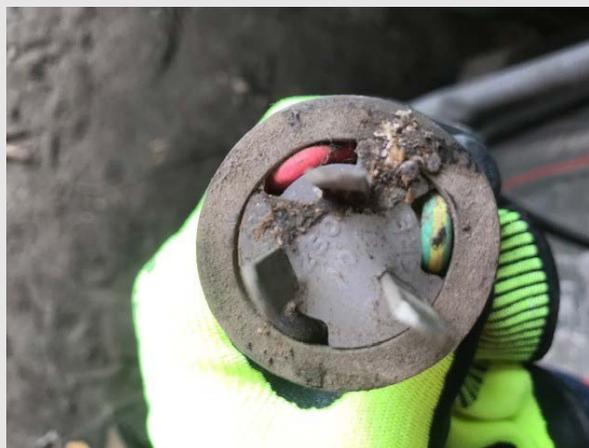
Dangerous incident  
IncNot0035043

A boilermaker was plugging in a lead to a site shed intending to supply power to lights. As he turned the powerpoint with his right hand, he felt an electric shock in his left arm and across his chest. His left hand was touching an I-beam. A supervisor was called and the power was isolated. The worker was assessed by ambulance officers and taken to hospital. The worker was cleared to return to work.

Workers should check that all equipment is fit-for-purpose before using it.

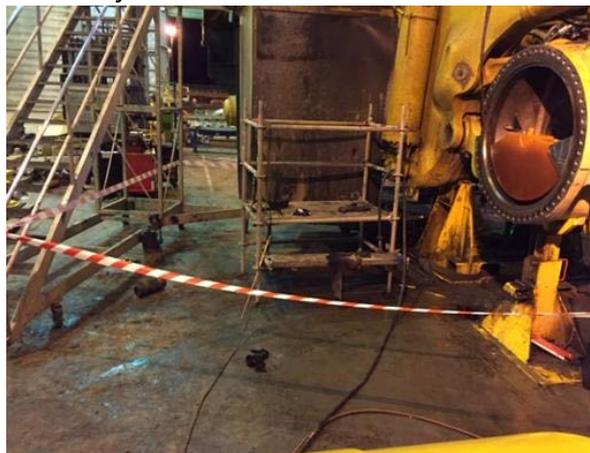
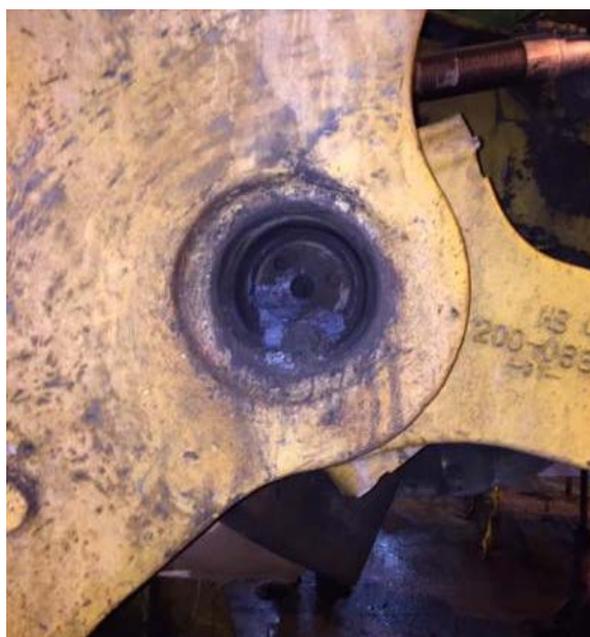
Dangerous incident  
IncNot0035054

A boilermaker was trying to remove a seized pin from a rear axle link in a dump haul truck. The pin was heated using a lance, then cooled using water. This process was repeated. As the worker applied water to cool the pin, an explosion occurred, ejecting the pin horizontally from the pin bore where it hit the left pelvis of the boilermaker and pushed him back onto a scaffolding frame. The pin weighed about 50 kilograms.

The scene was secured and the boilermaker was transferred to hospital. He suffered minor injuries.

Lancing and cooling is a regularly practice used to remove seized pins. However, the explosion that occurred was unprecedented and at the time of writing, not understood. The Regulator has commenced a causal investigation into the incident so that the circumstances can be better understood and lessons shared with industry.
