Significant Incident Report No. 254

Subject: Uncontrolled release of energy during removal of luffing cylinder pin

Date: 06 July 2017

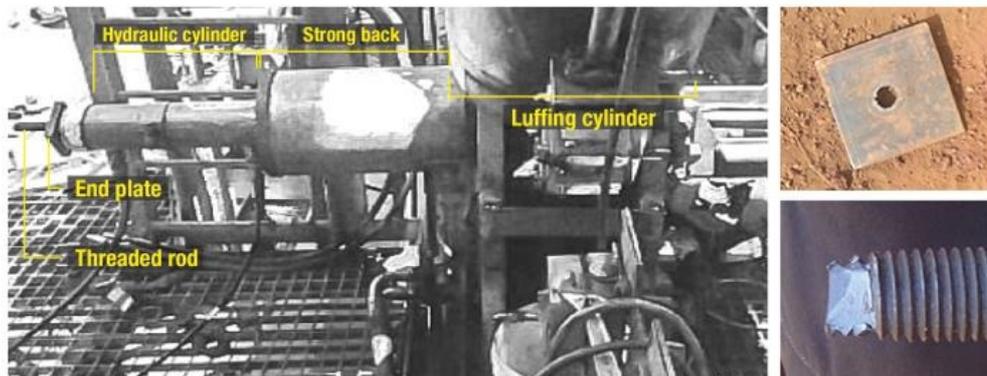
After the fifth attempt the threaded rod failed unexpectedly, releasing stored energy. The rod and end plate were ejected from the work area (on an elevated maintenance platform of the reclaimer). The end plate missed an operating crane and was found about 20 metres away on the ground.

Further investigation identified that the threaded rod had failed due to tensile overstress.

Left. Picture from the specialist contractor's safe work procedure illustrating the set-up of the implement.
Right. Ejected end plate (top) and failed threaded rod (below).

- The load applied by the hydraulic system exceeded the tensile capacity of the threaded rod.

- No safe operating limits were specified in the safe work procedure or job hazard assessment.

- There was inadequate safety-in-design consideration for the implement as the hydraulic system was capable of exceeding the breaking capacity of the threaded rod.
- Engineered protection devices (e.g. pressure relief device) were not designed or installed correctly to protect the system from inadvertent overloading.
- The controls for the safe use of the implement were not identified as inadequate in the risk assessment process.

- The threaded rod was not adequately rated or assessed by a competent person.

- Use competent person(s) to design and load rate all purpose-built mechanical tools or implements.
- Consider using engineering controls to mitigate the risk of overloading of mechanical systems (e.g. load limiting devices such as pressure control valves).
- Identify and document the operating limit or capacity of the purpose-built mechanical tool, in a safe work or operating procedure.

Note: The operating limit should be based on the published capacity of the components of the tool, determined using sound engineering principles, or have its upper limit tested in a safe environment.
