Week ending 30 May 2018

This incident summary provides information on reportable incidents and safety advice for the NSW mining industry. To report an incident to the NSW Resources Regulator: phone 1300 814 609 24 hours a day, 7 days a week.

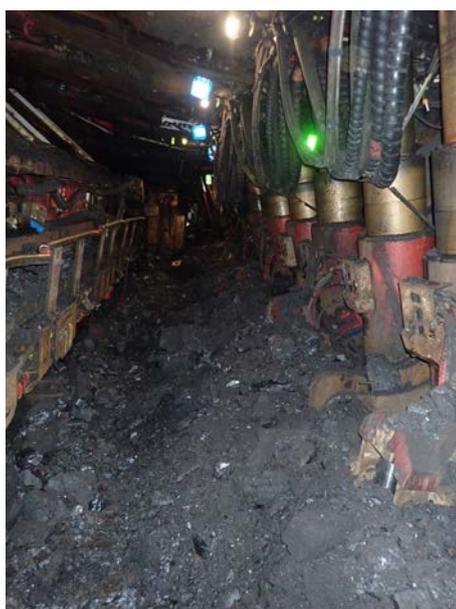
Dangerous incident
SinNot- 2018/00822

A coal burst occurred during longwall mining. Ejected coal was found in the walkway of the longwall. Face pressure was lost.

The Work Health and Safety (Mines and Petroleum Sites) Regulation 2014 has been updated to include coal burst at a mine as a dangerous incident.

Coal burst should be included in the mine's principal hazard management plan for strata for both longwall and development or considered as a stand-alone principal hazard management plan.

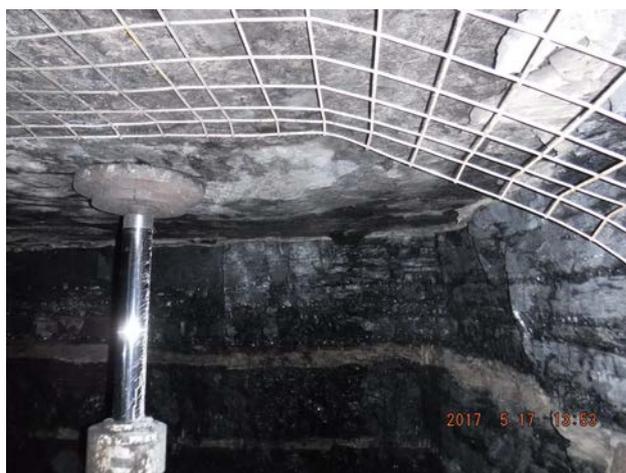
Dangerous incident
SinNot- 2018/00816

Coal and gas was ejected from the rib from the vicinity of a borehole. The power to the miner was tripped by the methanometer. There were three operators at the miner at the time of the incident. One operator suffered bruising and abrasions when he fell while clearing the area. The scene was preserved immediately however was later disturbed by mine workers.

When scene preservation is required the mine must take all necessary steps to prevent people from disturbing the scene. This may include placing sentries.

Section 17 of the [Work Health and Safety \(Mines and Petroleum Sites\) Act 2013](#) allows for treatment of injured workers, activity to make an area safe and actions directed by an inspector irrespective of any non-disturbance requirements. Mines should have in place systems of work for mining in proximity of boreholes.
