WEEKLY INCIDENT SUMMARY

Week ending Friday 28 June 2019

Mine safety reference ISR19-25

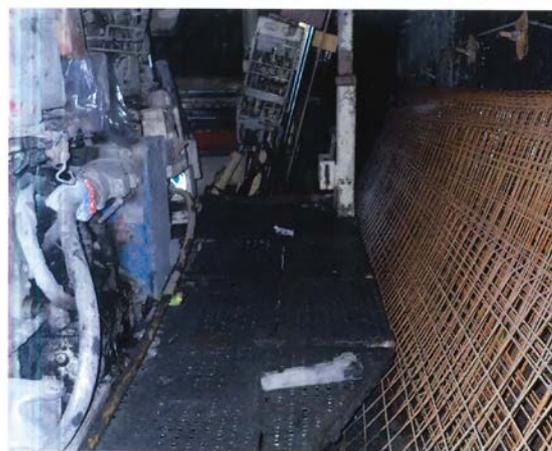
INCIDENT TYPE	SUMMARY	RECOMMENDATIONS TO INDUSTRY
Dangerous incident IncNot 0034938	<p>When carrying out repairs to a broken conveyor chain on a continuous miner, a flight bar became jammed in the foot sprocket. This occurred while pulling the chain on with a winch rope.</p> <p>This resulted in the flight bar snapping and being ejected. Part of the flight bar hit a worker on the left shoulder. The worker was positioned to observe the chain run around the foot sprocket, while standing on the bolting platform.</p>	<p>Mines must have procedures in place when any lifting/pulling configuration is set up. The procedure must include where the low energy break point of the system is located. Safe standing zones must be established with consideration of all potential system failures.</p>
