Class 1P Lessons Learned

(March / 2019)

Event No:		Event Date:	20 th March 2019
Incident Type:	LTI		
Project:			
Business Unit:	Infrastructure		
Incident Classification:	2A/1P

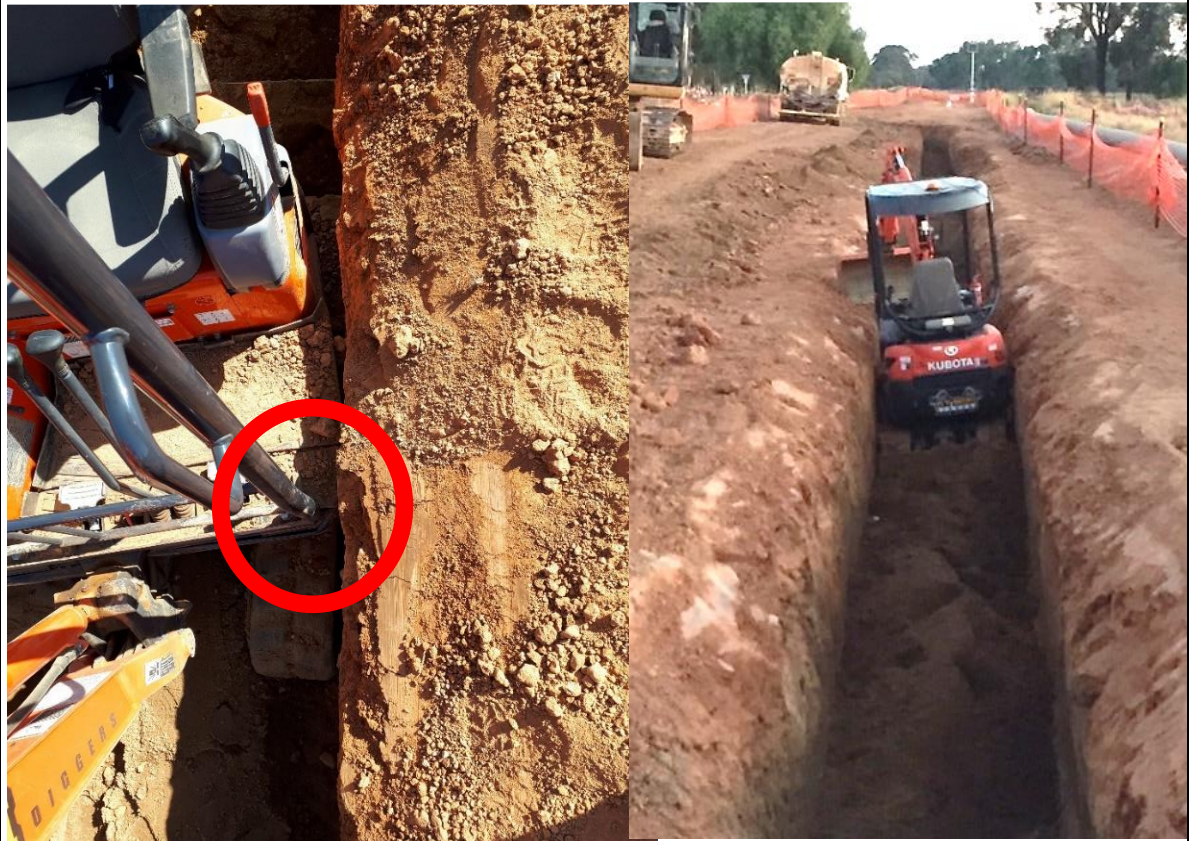
Photos / Sketches:

Description of Incident:	<p>A subcontractor operator was involved in an incident that resulted in a fractured lower left leg. The operator was operating a 1.7 tonne excavator in the bottom of the 1.4-metre deep trench. The excavator was 0.8 metres wide and the trench was 1.0 metres wide, allowing minimal clearance on either side of the excavator.</p> <p>The subcontractor was placing bedding sand into a trench (1.4 metres deep) using a live bed trailer. The sand was being spread utilising a mini (1.7 tonne) excavator, which had been driven into the trench via a ramp. As the excavator was reversing, the operator believes his left leg extended outside of the ROPS stanchion and that he accidentally contacted the slew control lever. This caused the excavator to slew to the left, jamming his leg in between the roll over protection stanchion and the side of the trench, fracturing the lower left leg.</p>

<p>Key Contributing Factors:</p>	<ul style="list-style-type: none"> • Placement of bedding was excluded from the activity main steps and not included in the risk register. • Did not identify placement of bedding as a risk. • AMS not developed as effectively as required under SQERM process. • SQERM process not effectively followed or understood. • XX did not review or sign off the TRA. • Changed methodology for placement of bedding not reflected in documents. • Small excavator was placed in the bottom of the trench resulting operator being exposed to high risk. • XXXXXXXXX and Subcontractor personnel failed to identify the risks associated with the excavator in the trench.
<p>Preventative Actions:</p>	<ul style="list-style-type: none"> • Accountable culture tool applied to persons involved. • Superintendent and supervisor to present to the team and subcontractor forum on lessons learnt to assist in culture step change. • Risk-based review of resources with respect to supervisory and engineering coverage to be undertaken across the Project. • Development of updated AMS with subcontractor and client prior to possession of site from XX being granted. • Subcontractor supervisor to be approved by superintendent and client prior to possession of site from XX being granted. • Review of all current SQE documentation in place across project, with subcontractors. • Internal HSE System audit to be undertaken by XX regional team. • XX to provide mandatory training on SQE requirements for all new subcontractors. • All relevant Project AMSs and TRAs to be reviewed to ensure that they address the placement of pipeline bedding. • XX delivery, HSE team and subcontractor supervisors to attend Change Management toolbox training session. • All field delivery team members to attend a toolbox training session on identifying triggers for change management and when to review a TRA. • At the 4 Weekly Look Ahead, Safety and Environment Managers and Superintendent to be involved and set the high-risk activities inspections for the upcoming week and allocate responsible individuals.

<p>Key Lessons Learned:</p>	<ul style="list-style-type: none"> • A clear methodology for all tasks needs to be determined and agreed prior to works commencing and all methodology changes must go through the change management process. • The SQERM process is to be followed and all parties must be involved in the AMS development. • There was a clear lack of understanding around the change management process by both XX and the Subcontractor. • SQE processes are not being consistently followed on the Project. • XX personnel not taking accountability for the Principal Contractor role of on the project as they incorrectly assumed the risk was with the Subcontractor. • Governance activities need to be more deliberate to improve HSE performance of subcontractors. • HSEMP was generic and needed to be more project specific and governance was required to ensure the project was adhering to the HSEMP.
<p>* Recommendations to embed lessons across the group</p>	<ul style="list-style-type: none"> • Ensure that the XX SQERM processes are clearly understood and followed by both XX and subcontractor personnel. • Key subcontractor personnel to undergo XX SQERM training. • Post investigation, a safety re-set to confirm safety expectations on the Principal Contractor.
