WEEKLY INCIDENT SUMMARY

Week ending 2 May 2019

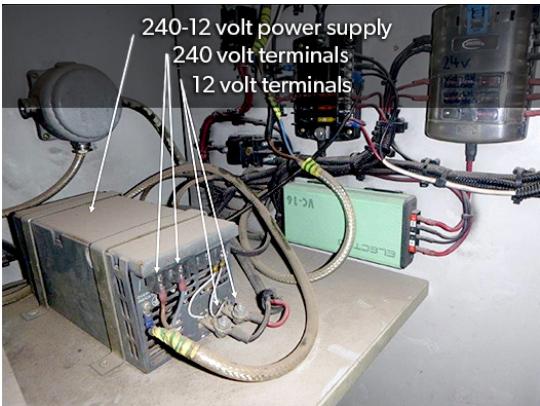
INCIDENT TYPE	SUMMARY	RECOMMENDATIONS TO INDUSTRY
Dangerous incident IncNot0034469	A fitter suffered an electric shock in an underground metalliferous mine while trying to identify a fault in a tele remote loader hut. The fitter's hand contacted the 240-volt terminals on a power pack.	Mine operators must ensure only suitably qualified personnel work on electrical apparatus. Isolation and testing for dead are critical to ensure electrical safety. Terminals are to be appropriately labelled and suitably shielded for their environment.

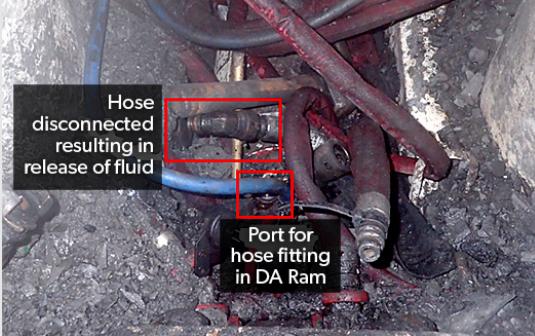
INCIDENT TYPE	SUMMARY	RECOMMENDATIONS TO INDUSTRY
Dangerous incident IncNot0034473	<p>A release of under pressure fluid occurred on a longwall face. A fitter was replacing a hydraulic hose on a roof support which had been damaged by stone. The fitter had isolated and dissipated system pressure. When the staple was removed from the hose, it whipped, striking the fitter in the hand. The fluid stream sprayed the fitter, dislodging his hard hat and safety glasses. The fitter was taken to hospital as a precaution and was cleared of injury.</p>

<p>Where stored pressure can remain in a circuit (such as check valves and load lock valves), appropriate methods must be available to safely dissipate pressure.</p> <p>Mine risk assessment on hydraulic systems must identify and provide effective controls for areas of trapped pressure.</p>

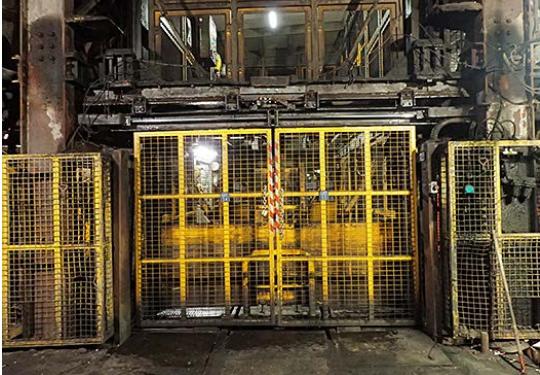
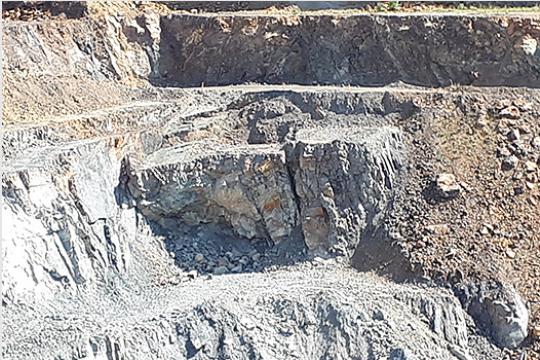
INCIDENT TYPE	SUMMARY	RECOMMENDATIONS TO INDUSTRY
Dangerous incident IncNot0034478	<p>A large fall of ground, measuring approximately 10 metres by 10 metres, occurred in a quarry when a wedge, within a working face, slipped approximately 1 metre. There were no workers at the mine when the event occurred.</p>

<p>All mines with highwalls should complete geotechnical assessments to determine the design of the highwall. All geological and geotechnical issues need to be considered and highwalls designed accordingly.</p>

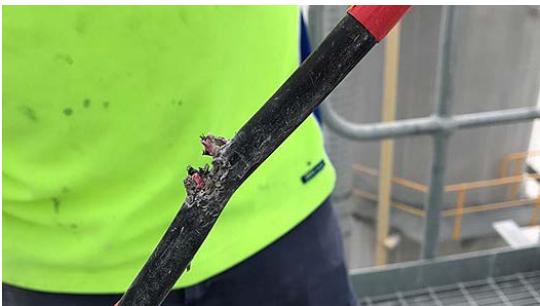
Dangerous incident IncNot0034514	<p>A worker in a quarry suffered an electric shock while a fitter was operating a 240-volt winch. While using the winch, the worker's hand contacted a damaged section of the power cord, resulting in an electric shock.</p>

<p>Mine operators must have systems and checks in place for workers to complete pre-use inspections of portable electrical hand tools and monitor worker compliance. Workers must inspect any tools and equipment being used to ensure they are fit for purpose and free from damage.</p>
