Week ending 2 May 2018

This incident summary provides information on reportable incidents and safety advice for the NSW mining industry. To report an incident to the NSW Resources Regulator: phone 1300 814 609 24 hours a day, 7 days a week.

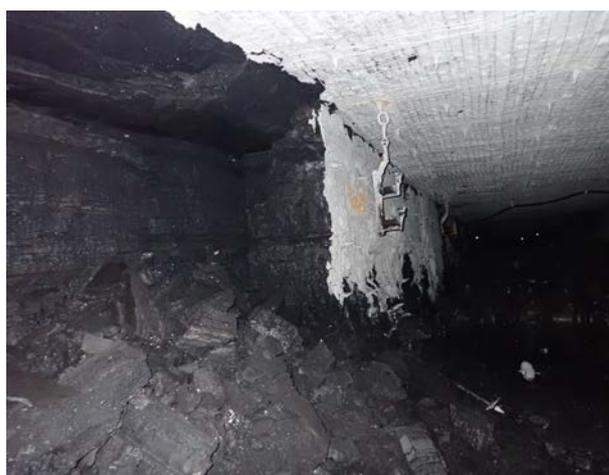
Serious injury
SinNot-2018/00638

At an underground coal mine, a worker suffered a broken ankle when a slab of coal hit him. The slab was reported to be about 1 m high and 0.5 m thick and broke away from the upper rib.

A section 195 notice was issued to the mine operator prohibiting mining activity at the location until a detailed investigation has been completed.

Rib conditions and the suitability of installed support should be monitored on an ongoing basis. Any issues identified should have corrective actions planned.

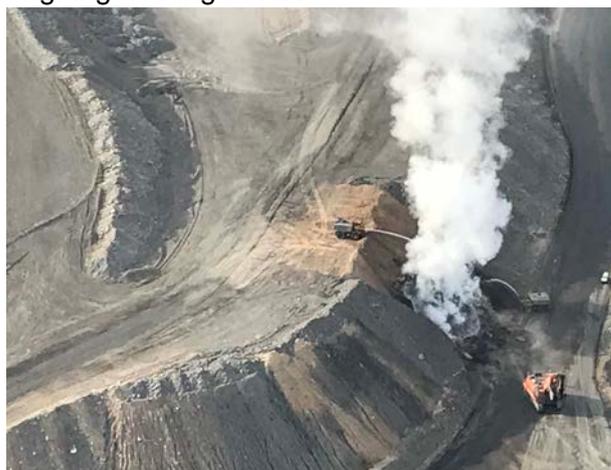
Severe incident
SinNot- 2018/00623

A spontaneous combustion event at an open cut coal mine was reported to the Resources Regulator, but it had not been notified by the mine. The mine was responding to an ongoing heating event.

The Work Health and Safety (Mines and Petroleum Sites) Regulation 2014 has been amended to include spontaneous combustion at a coal mine as a dangerous incident.

Mines should review the updated legislation to ensure compliance with all notification requirements.
