WEEKLY INCIDENT SUMMARY

Week ending 10 May 2019

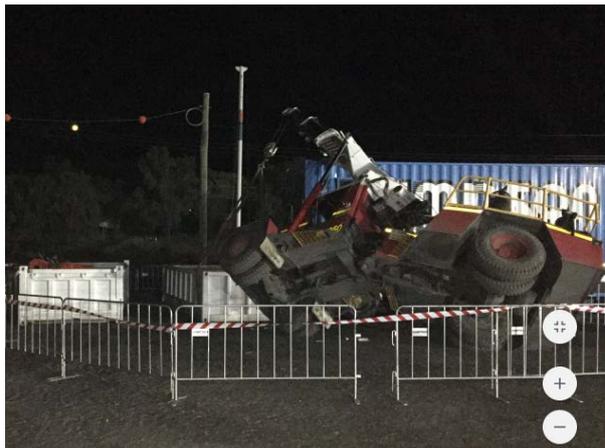
INCIDENT TYPE	SUMMARY	RECOMMENDATIONS TO INDUSTRY
Dangerous incident IncNot0034556	A 20 tonne crane rolled over. The crane was travelling while carrying a load and rolled over while attempting to turn. The boom came to rest against an adjacent container. No workers were injured.	When planning travel paths for mobile cranes, the path must be inspected and load charts must be assessed to confirm the crane will remain within safe operating limits.

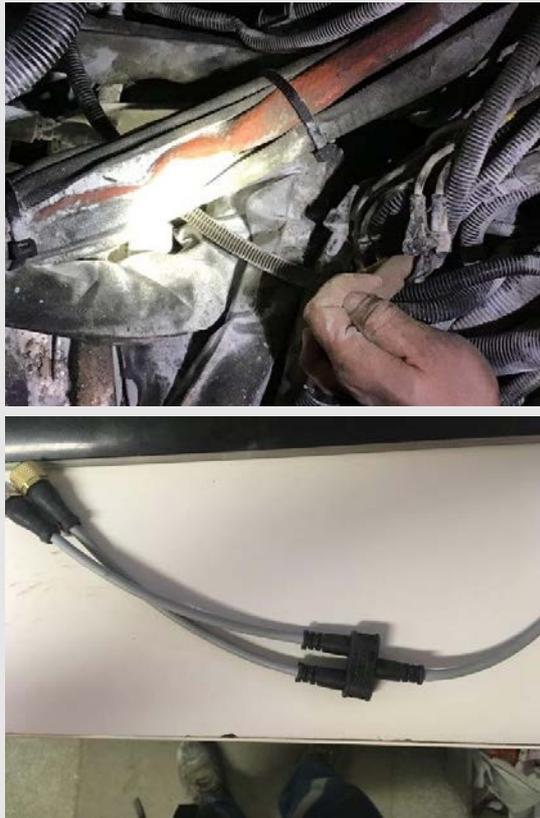
Dangerous incident
IncNot0034518

A fire occurred on a loader in an underground metalliferous mine. A worker reset a circuit breaker while fault finding, which caused an upstream circuit board to trip, resulting in a short circuit and an electrical fire. The fire was extinguished by a hand-held extinguisher.

When fault finding on electrical circuits, workers must use test equipment to identify possible short circuits. Workers should-not rely on resetting circuit breakers to find faults.

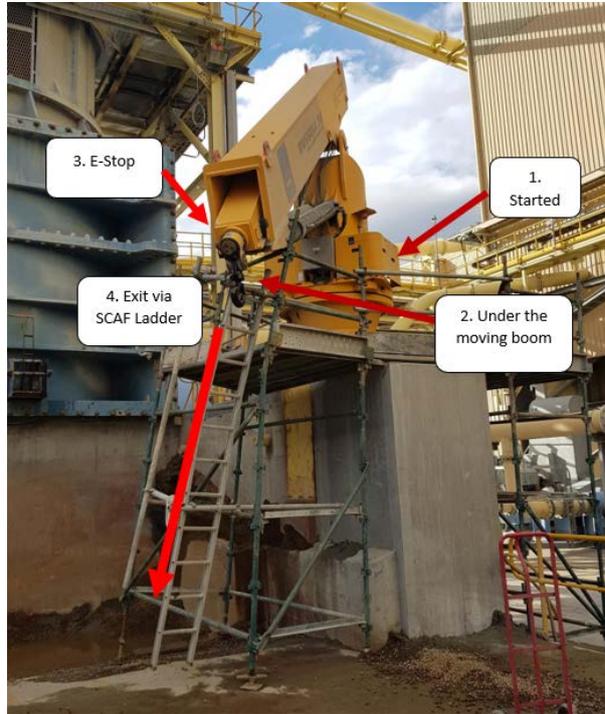
Dangerous incident
IncNot0034536

An unplanned movement occurred on a crane at a processing plant. During scheduled maintenance, the pendant controller was left attached to the crane and exposed to rain. During commissioning, the crane moved towards a worker and struck scaffolding that was erected around the crane. The worker hit the emergency stop on the pendant, but it failed to stop the crane. Another worker successfully stopped the crane by using an emergency stop on a fixed control box.

The cause of the water ingress was due to modifications to the remote by the distributor, which rendered the manufacturer's controls ineffective.

The ingress protection (IP) rating of plant is critical for its safe use and must be maintained. Plant that has been exposed to water or heavy rain must be checked before being used.

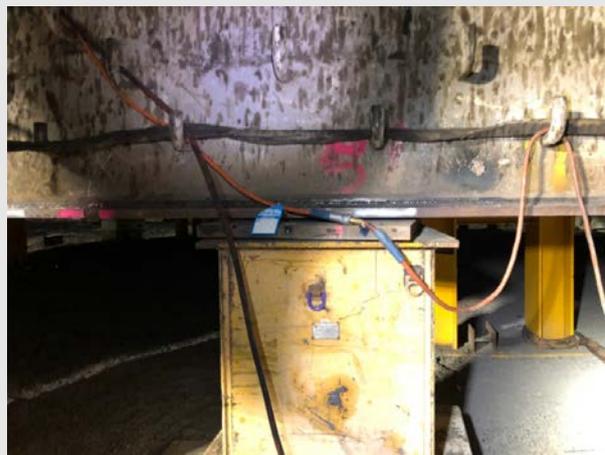
Dangerous incident
IncNot0034538

A rigger suffered an electric shock at a dragline overhaul site while cleaning welding equipment. The rigger had difficulty splitting a welding lead coupling and applied extra force. This resulted in the rubber sheath being dislodged and exposing the brass coupling pin that contacted the worker's gloved hand. The exposed pin contacted the surrounding steel, striking an arc.

Welding machines must be isolated when not in use. Workers who are given tasks to clean work areas must be given clear instructions and must confirm that equipment is isolated before commencing work.

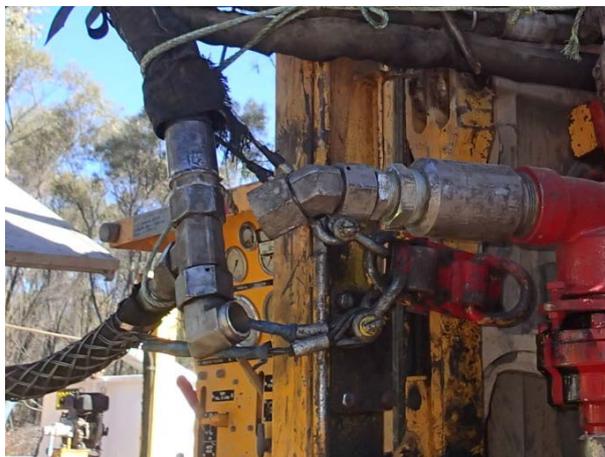
Serious incident
IncNot0034559

A worker was injured when a compressed air fitting failed. The worker was hammer drilling on air when the fitting broke and air was released. The worker fell off the work platform. The hoses were restrained and did not hit the worker. Another worker shut down the compressor to stop the flow of air. The worker was transported to hospital, kept overnight for observation and released the following day.

Daily inspections should include compressed air hoses, fittings and whip checks. Compressed air systems should be assessed for the risk of whipping hoses and controls, such as whip checks, should be put in place.
