WEEKLY INCIDENT SUMMARY

Week ending Friday 31 May 2019

This incident summary provides information on reportable incidents and safety advice for the NSW mining industry. To report an incident to the NSW Resources Regulator: phone 1300 814 609 24 hours a day, 7 days a week.

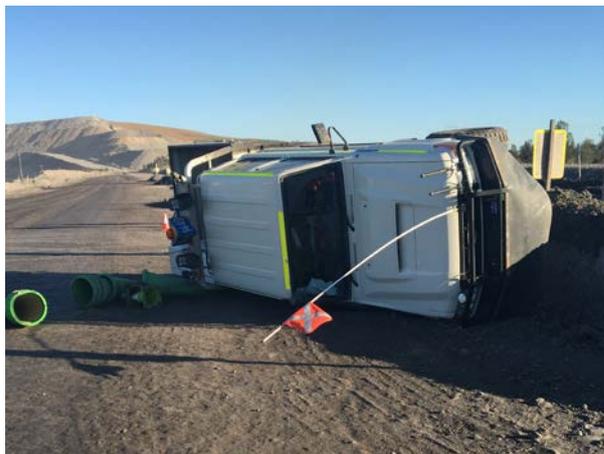
Dangerous incident
IncNot0034701

A light vehicle rolled in an open cut coal mine. The vehicle was exiting a crib hut park-up area. As it turned onto the road, the driver was distracted by a noise and the sun affected the driver's vision. The vehicle hit the centre island and rolled onto its side. The driver climbed out of the vehicle uninjured.

Drivers must maintain focus on the task at hand. When there is a distraction, the driver should find a safe place to stop and address the issue rather than risk causing an incident by trying to fix the problem while driving. Roadway and intersection designs must consider all environmental factors including sunlight, fixed lighting, visibly etc.
