## Misfires found days after shot

16 February 2018

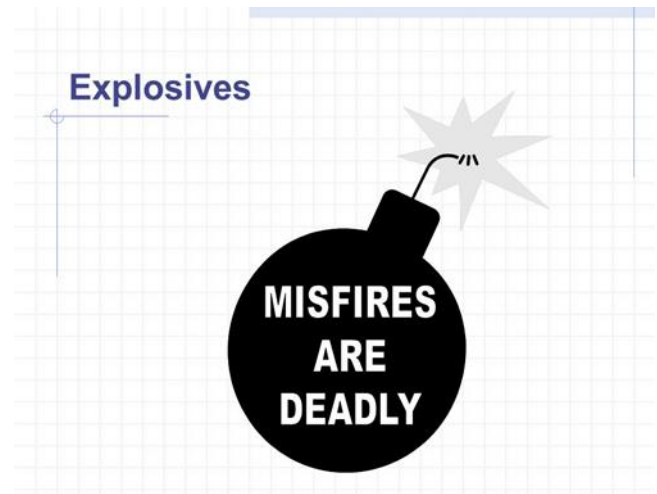
An operator was checking the area behind a shot that had been fired a few days earlier when he spotted two holes that had not fired. The area was immediately barricaded, and misfire procedures carried out.

On the day of the shot there were two holes loaded on a level five metres above the main pattern. The blasting time had been brought forward due to heavy fog in the area.

The shotfirer and the blast crew member had walked the pre-blast pattern to ensure the holes were all connected and accounted for correctly, checking that the hole count matched the total number of boosters and detonators being used for this blast.

We recommend that all sites review blast procedures, and misfire procedures, to ensure that:

- **Adequate pre-blast inspections are carried out to identify the potential for misfires.**
- **Adequate post-blast inspections are carried out to identify misfires or other potential hazards associated with the shot, before the area is declared safe to enter.**
- **Contractor management procedures include checks on Blast Management Plans and blasting procedures.**
- **Regular inspections are made of blasting activities.**
