Significant Incident Report No. 270

Subject: Operator trapped between EWP and overhead structure

Date: 15 November 2018

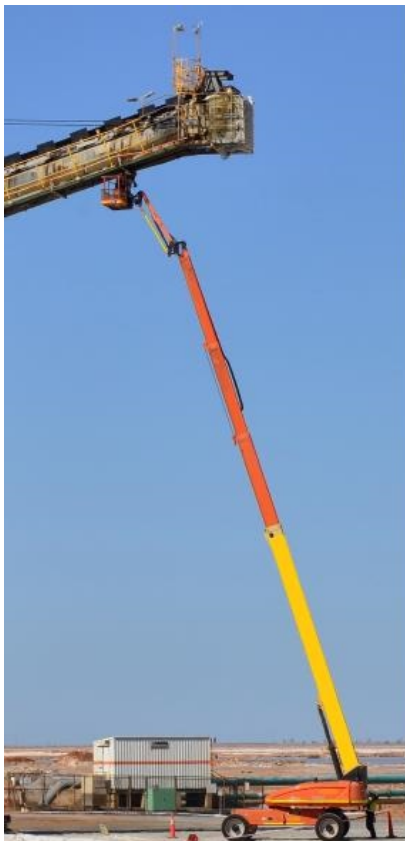
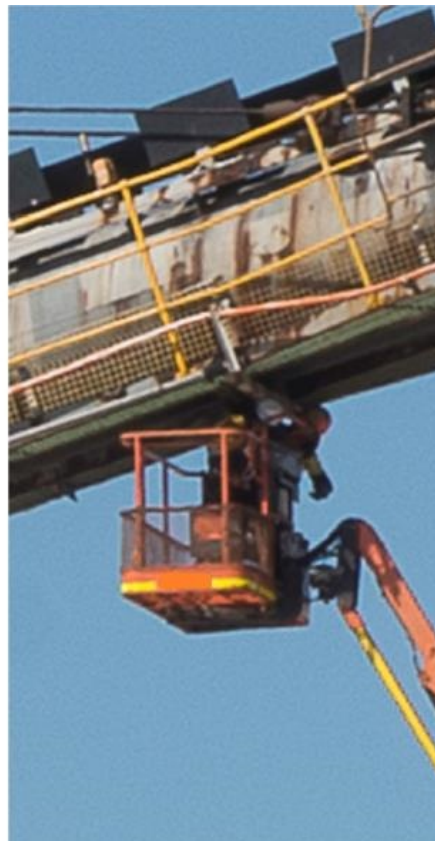
Elevating work platform operator trapped against underside of conveyor structure

The operator was leaning over the controls when he moved the EWP basket upwards, trapping him against the conveyor structure above.

- The job hazard analysis (JHA) did not identify the hazard of being crushed against the stacker.
- The EWP basket was directly below and in close proximity to the stacker conveyor frame.
- The EWP operator activated the boom extend function instead of boom retract.
- The EWP function speed control was set in fast mode (rabbit) instead of slow mode (tortoise).
- Although activation of the secondary guarding sensor bar prevented further movement of the EWP basket, it did not retract the basket due to insufficient continuous pressure being applied.
- There was a delay in bringing the basket to the ground, as the spotter was unaware of the boom operating envelope programmed into the EWP safety system.

- Before undertaking work involving EWPs in the vicinity of fixed structures, ensure the potential hazard for workers to be crushed is identified, and effective controls implemented to prevent exposure to the hazard.
- Ensure that the emergency plan for EWP work in restricted-access areas includes a suitable response to entrapment or entanglement within a structure.
- Where there is a risk of crush injury to a person in an EWP from an overhead fixed object, use EWPs fitted with engineering controls such as protective cages and sensor devices.
- Implement positive communication protocols between all personnel involved in the work.
- Ensure all workers involved in the operation of an EWP have received adequate training and verification of competency for the equipment being used.
