Weekly incident summary

Week ending 18 October 2017

This incident summary provides information on reportable incidents and safety advice for the NSW mining industry. To report an incident to the NSW Resources Regulator: phone 1300 814 609 24 hours a day, 7 days a week.

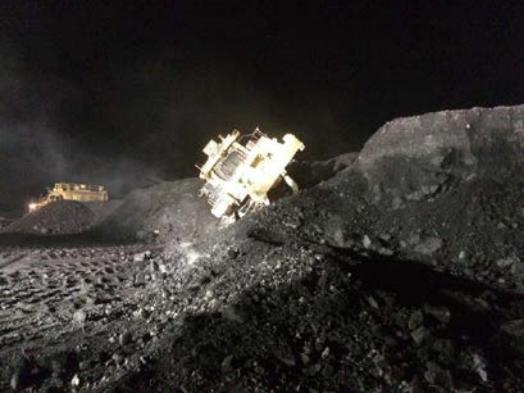
Incident type	Summary	Recommendations to industry
Dangerous incident SinNot 2017/01651	<p>A run of mine (ROM) coal stockpile was showing signs of spontaneous combustion. A dozer was being used to push coal. The operator drove the dozer to the top of the stockpile. The dozer then slid down the stockpile sideways approximately 2.5 m.</p> <p>The operator suffered some bruising from the seat belt. The operator was experienced with dozers, however he was not experienced with ROM coal stockpiles.</p> <p>The incident was reported as a high potential, however it should have been reported as a dangerous incident.</p>

<p>Operators are reminded of the potential hazards associated with a dozer on a stockpile.</p> <p>The recommendations in MDG28 Safety for stockpiles and reclaim tunnels should be considered.</p> <p>Dozer operators should have appropriate experience for the task.</p> <p>Mines should ensure all supervisors and workers are trained to identify and notify incidents when a notifiable incident occurs.</p> <p>A dangerous incident (as prescribed in cl179 of the WHS (MPS) Regulation 2014) must be reported immediately to 1300 814 609 and the incident site must be preserved until an inspector arrives on site or otherwise directed by a government official from the regulator.</p>

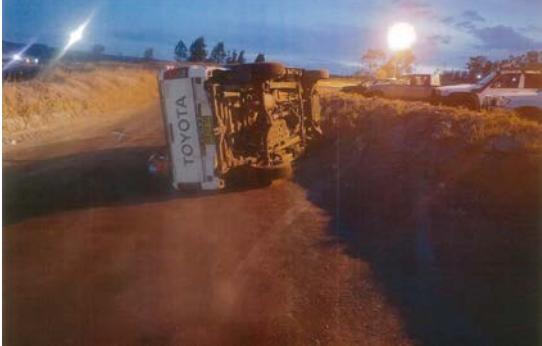
Dangerous incident SInNot-2017/01662	A supervisor was driving a light vehicle from a pit office area to the stores. While driving up hill and turning a corner, the driver went to apply the brake but accidentally applied the accelerator. The vehicle hit a bund between the car park and store access road and rolled the vehicle on to its side.

Light vehicle operators should consider the potential issues that may affect their foot controls while driving light vehicles, such as clothing and footwear. Seat belts should be worn at all times. Site speed limits should be enforced.
Dangerous incident SInNot-2017/01661	A fitter jump-started a light vehicle that had a flat battery. The vehicle was parked outside a workshop. The fitter walked back to the workshop to return the jumper leads. While he was away from the vehicle, it rolled about 30 m and collided with an articulated water truck. When the fitter came back from the workshop and noticed the vehicle had rolled away and hit the water truck, he ran to it and stopped the engine, put it in gear and applied the handbrake.

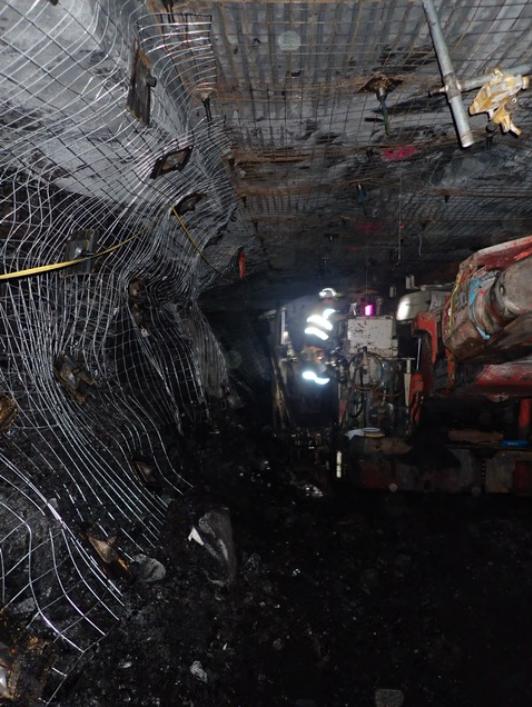
<p>secured and the workers were uninjured. A large scale 'pressure bump' resulted in the displacement of coal from the rib over a distance of approximately 3m. Workers at the face observed the ejection of coal, however did not immediately recognise it as a coal burst.</p> <p>An independent geotechnical engineer and the mine's geotechnical engineer inspected the area and determined the incident to be a coal burst.</p> <p>Normal mining production was taking place at the time. The area is heading towards the swamp fault zone and had reduced the spacing's between the cutting test as per the mine's plan. A cutting test was taken 1 m before and was deemed to be okay.</p>

<p>activity.</p> <p>The predictability of coal burst is not precise and, as such, mine operators should consider that where an increased coal burst potential has been identified, due to the presence of geological structure or change in stress regime, control measures should be implemented that remove workers from the place of risk.</p> <p>Refer to:</p> <ul style="list-style-type: none"> - IIR16-05 Austar coal burst - Double fatality at Austar Coal Mine on 15 April 2014

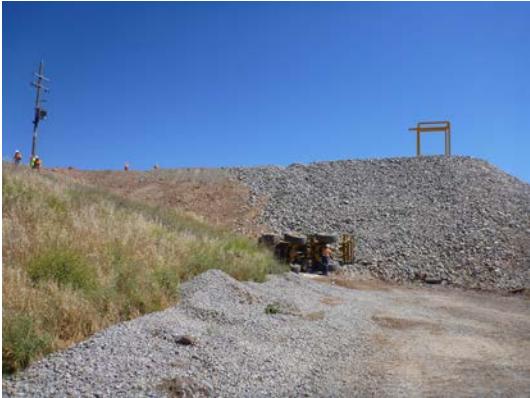
Dangerous incident SinNot 2017/01629	<p>An IT (integrated tool) carrier was travelling down the bank of a tailings dam. The machine lost brakes at the top section and the operator continued to steer the machine with increasing speed. The operator jumped from the machine which continued out of control through a windrow and dropped a further 10 to 12 vertical metres where the it rolled over, coming to rest on its side.</p>	<p>Mine operators should:</p> <ul style="list-style-type: none"> • provide fit-for-purpose windrows as a mitigated control when an operator has lost control of their mobile plant • ensure brake systems remain functional • ensure pre-start checks include brake functionality • ensure operators are trained in

<p>emergency procedures.</p> <p>Refer to:</p> <p>SB17-01 Industry reports more truck rollover incidents.</p> <p>SB10-03 Mobile plant - safety critical systems</p> <p>SA06-12 Maintenance of Safety Critical Systems - Braking, Steering & Warning Systems</p>
Dangerous incident SinNot 2017/01628	<p>A loaded mining truck had completed loading and was leaving the loading area when it collided with another unloaded mining truck that had just travelled down the ramp. The collision occurred at the base of a ramp.</p>
