Rock from tyre blow out hits excavator

8 December 2017

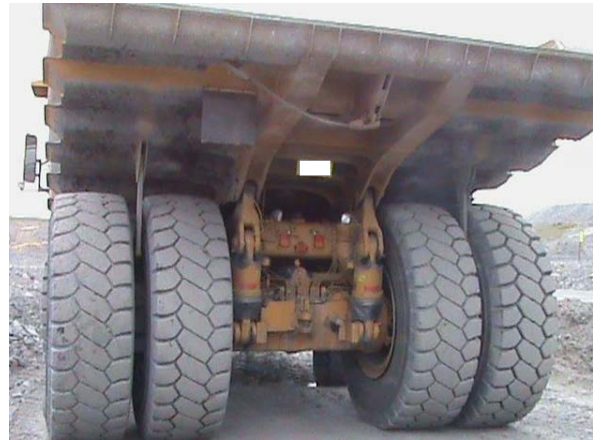
A dump truck was backed under an excavator while being loaded by the excavator. Once loaded the dump truck proceeded to pull away from the excavator at which time Pos 4 tyre (the tyre in position 4 on the dump truck) blew out ejecting a rock which smashed through the side window of the excavator. At the time, work was being done on haul roads at the site and it is believed that impact damage to the tyre may have caused the blow out.

This incident highlights the need to be vigilant with tyre maintenance and the condition of site roads. We recommend that all sites review procedures, and practices, to ensure that:

- **Procedures are in place to ensure regular checks and maintenance of tyres, including during pre-start checks**
- **Site roads are regularly maintained and are kept free of rocks and sharp objects that may impact on tyre wear**
- **Workers are trained in, and regularly reminded of, the potential results of tyre damage**
- **Regular workplace inspections are conducted to ensure compliance with the procedures listed above**
- **Review glass options in excavators, including consideration of laminated glass for all windows.**
