SHEQ ALERT

Reference number:	19-002
Title:	Insecure load – Low Loader

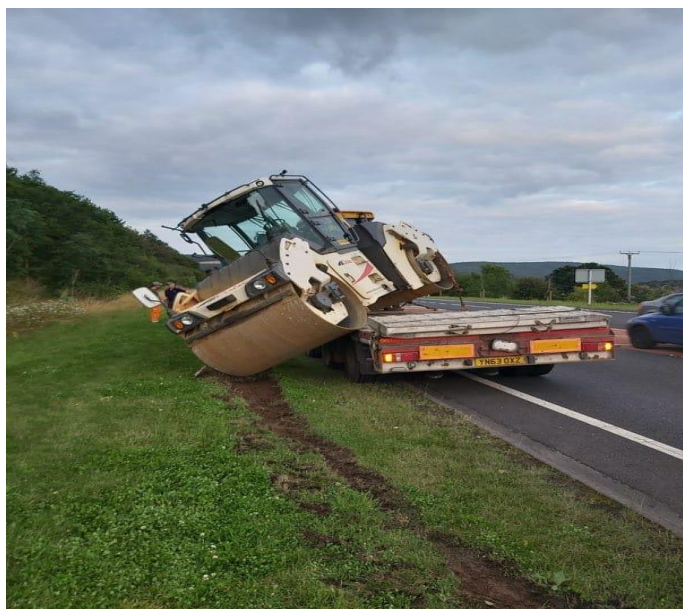
An incident occurred at approx. 20:05 on 5/08/19. A low loader, carrying a tandem roller and a JCB 3CX was travelling westbound along the A616 Deepcar. As it negotiated a small roundabout, the tandem roller moved and partially slipped off the low loader.

The low loader had been loaded at the depot by two operatives. They loaded a tandem roller and a JCB 3CX onto the low loader during the afternoon of 5th August 2019 in preparation for the delivery that evening. The low loader was travelling westbound along the A616 to the site, which was approximately 1.5km away. As the low loader was travelling around the roundabout, the tandem roller moved and slipped off the low loader. Initial investigations have determined that the tandem roller had not been secured satisfactorily for safe transportation.

- The loader did not complete the task.
- Only two chains were used on the roller rather than four.
- The driver failed to check the load
- Failure to recognise risk and act appropriately

- Review risk assessments and method statements (RAMS) for loading and unloading of ALL plant.
- Review supply chain RAMS and competencies.
- Ensure loading and securing of plant is properly designed and briefed.
- Use four chains per item of plant as a minimum. Use a minimum of four separate anchorage points
