## Week ending 26 September 2018

This incident summary provides information on reportable incidents and safety advice for the NSW mining industry. To report an incident to the NSW Resources Regulator: phone 1300 814 609 24 hours a day, 7 days a week.

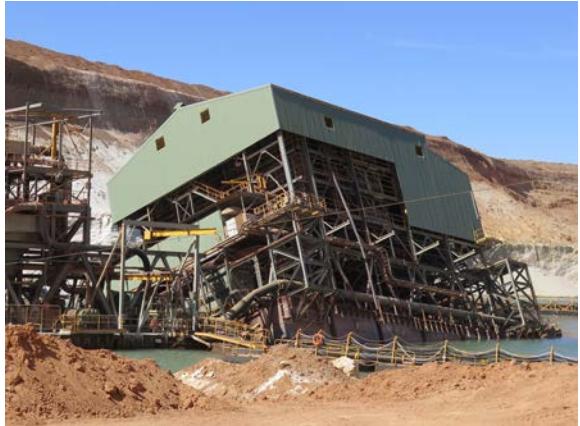
Dangerous incident SinNot-2018/01537	Two workers were required to evacuate a floating plant when it started to list. It only took 30 seconds for the plant to go from the starting position to the final resting	All vessels must be addressed in an emergency plan and workers should routinely

Incident type	Summary	Recommendations to industry
	<p>position. The plant only became stable when the suspected failed pontoon came to rest on the bottom of the dredge pond.</p>

<p>practice evacuation drills for a rapidly listing or sinking event.</p> <p>All vessels should have a stability and buoyancy assessment considering if there are any critical scenarios where a vessel could rapidly list or sink.</p>
Dangerous incident SinNot-2018/01526	<p>A bulldozer rolled in an open cut coal mine. An excavator and bulldozer were clearing old pillar workings when the bulldozer slid into the excavated workings (about 2 m) with the machine rolling onto its side. The operator was able to exit the machine and did not suffer any injuries.</p>
