## CAUSAL INVESTIGATION PRELIMINARY REPORT:

# Catastrophic engine failure in underground coal mine

- **Incident date:** 4 July 2017
- **Event:** Catastrophic failure of diesel engine system
- **Location:** Wongawilli Colliery, Wollongong, NSW

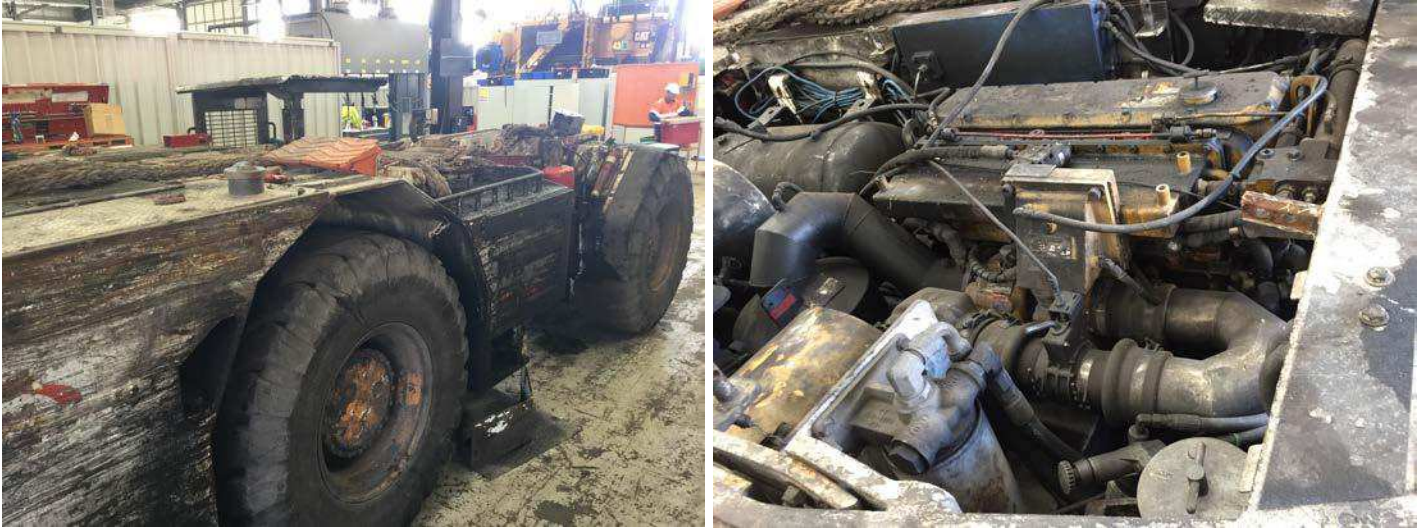
- While operating in an underground coal mine, a catastrophic failure of a diesel engine system occurred, resulting in hot internal reciprocating components being ejected through the engine block and exposing them to the mine atmosphere. This created an ignition source which has the potential to cause an explosion of methane gas.

**Engine failure:** The FBL10 involved in the incident (left), and internal engine components (right). Photos: Resources Regulator.

A scene preservation notice was issued and the machine was seized. It was removed off-site for inspection by an independent assessor. Visual inspections indicated a damaged oil supply pipe. This may have been a result of the engine failure or it may have been a precursor to the engine block failure. The causal investigation will seek to identify the exact causes of the failure.

- mine operators ensure maintenance of diesel engine systems and inspection and testing of the safety-related components and systems be carried out in accordance with recommendations of the vehicle original equipment manufacturer, the engine manufacturer and the ExDES registration holder.
- when designing explosion-protected diesel engine systems, it is essential that rare malfunctions causing ignition hazards are considered during the design risk assessment process. Refer to [MDG 43 Technical Standard for the design of diesel engine systems for use in underground coal mines](#).
