METAL / NONMETAL

Serious Accident

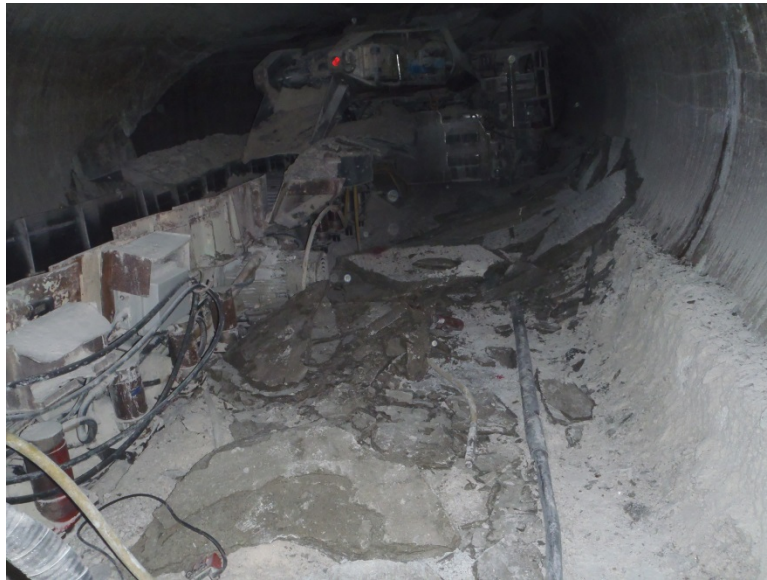
Trona - Underground – A fall of back/roof of approximately 50 feet long and 6-inches to 3-feet in thickness covered a continuous miner and a miner working close by. There was an operator in the cab of the continuous miner who was not injured. The miner working close by was moving a water hose when he was hit by the fall and suffered serious injuries.

- Make frequent examinations, and be alert to changing conditions which may affect back/roof conditions.
- Install additional roof and/or rib support when adverse conditions are encountered or anticipated.
- Where appropriate, use extra support in the vicinity of the last row of bolts to prevent a roof fall that initiates in the unbolted cut from extending outby.
- Use test holes to check for cracks and other hazards above the roof bolts.
- Tell mine management and other miners about unusual roof or rib conditions.
- Ensure areas where persons work or travel are supported before beginning work.
