## Week ending 1 and 8 August 2018

This incident summary provides information on reportable incidents and safety advice for the NSW mining industry. To report an incident to the NSW Resources Regulator: phone 1300 814 609 24 hours a day, 7 days a week.

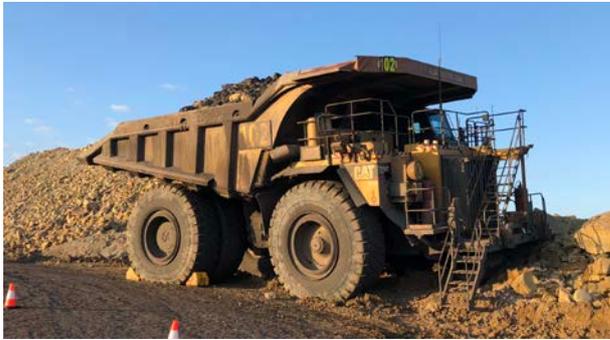
Incident type	Summary	Recommendations to industry
Dangerous incident SinNot-2018/01261	<p>A haul truck hit a windrow after the operator claimed to have had a microsleep.</p>

<p>When incidents occur and a microsleep is suspected, the mine must investigate and confirm that a microsleep has occurred and no other issue has contributed to the incident. If the microsleep is confirmed, the mine must comply with clause 11 Work Health and Safety (Mines and Petroleum Sites) Regulation and review control measures including the mine's fatigue management plan.</p>
Dangerous incident SinNot-2018/01255	<p>Falling coal hit three workers while they were hanging rib mesh in an underground coal mine. One worker was knocked to the ground, another worker was hit on the elbow and a third worker suffered a strain injury.</p>	<p>While installing support underground, workers must not place themselves in a position where they are under unsupported strata. The use of temporary strata support must be considered when developing job procedures.</p>

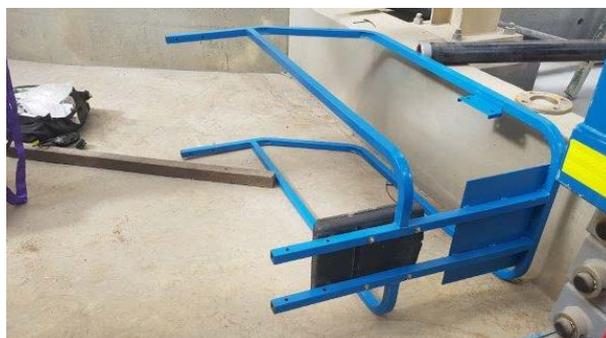
Serious injury  
SinNot-2018/01242

A contractor fell from the deck of a lowered scissor lift in a processing plant. The worker had unbolted the handrail and was manoeuvring the machine around steelwork. When the machine stopped, the handrail moved and in the process, the worker fell forward off the scissor lift. The contractor's harness he was wearing was not attached to the machine.

Operators must not modify safety devices fitted to plant without following mine procedures.

Mines must have systems in place to risk assess, control and manage changes required to safety devices.

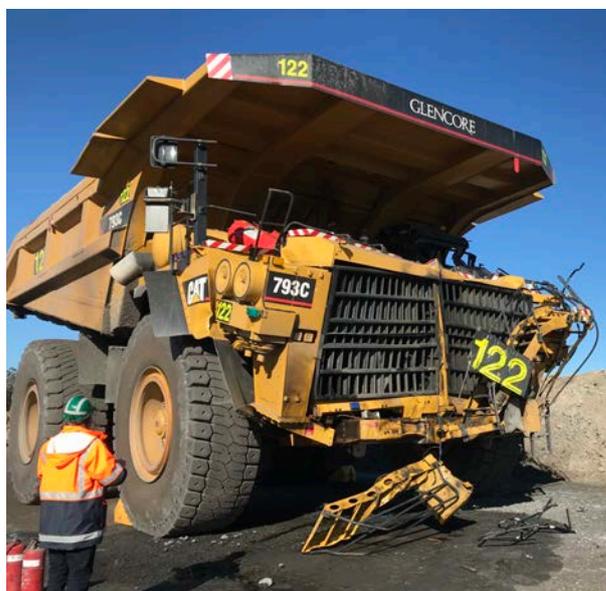
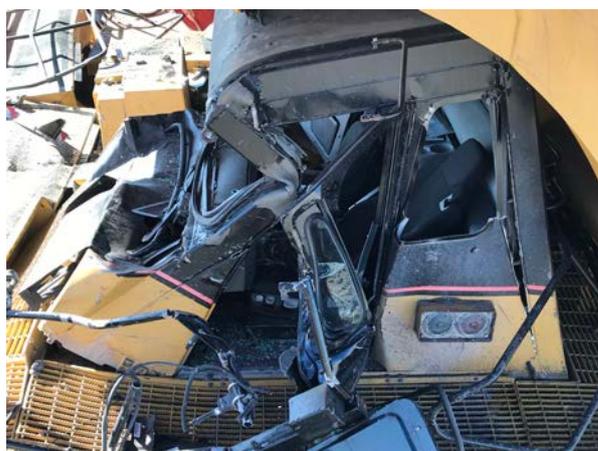
Dangerous incident  
SinNot-2018/01208

A truck driver suffered a broken tibia and knee cap when the haul truck he was driving collided with the rear of a stationary haul truck. A truck had stopped to give way to other vehicles at an intersection in accordance with site rules. As the second truck approached, it collided with the tray of the stationary truck. The stationary truck was pushed forward about 17 metres. The rear haul truck was substantially damaged and the site's mines rescue team was required to extract the injured worker from the cab.
