# NZ Safety Alert

14 June 2024

## Dislodged roller falls from height

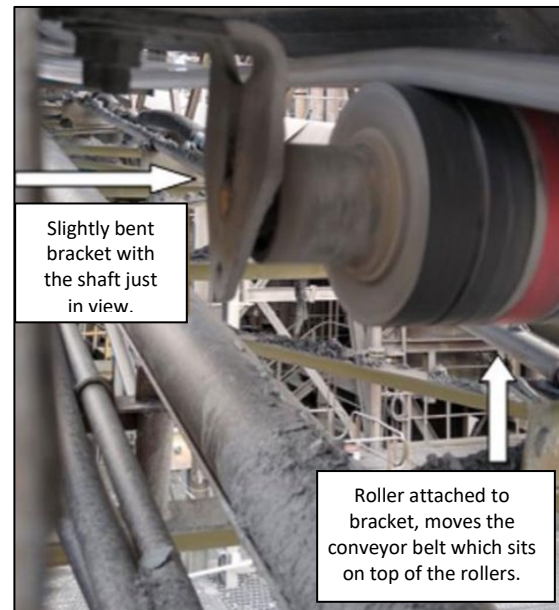
A return roller dislodged from a conveyor during operation and fell approximately 8 metres to the ground.

There were no retaining notches in the roller shaft, which allowed the roller to become dislodged from the bracket and fall to the ground.

1. Regular workplace inspections are conducted to ensure work areas are cleared free from fall hazards prior to allowing access.
2. You review rollers on conveyors to ensure the correct roller spindle type is being used on each conveyor system.
3. You review how rollers are accessed for repair or replacement to ensure hazards are identified and appropriately managed.
