# Safety Alert

16 August 2024

## Fatal digger accident

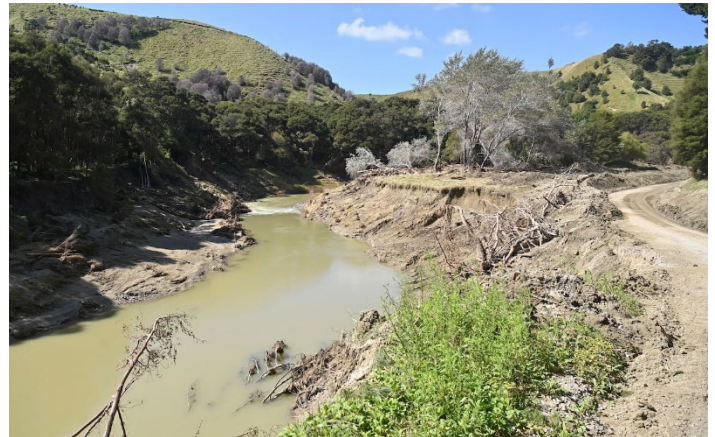
A worker was operating a 30-tonne excavator to remove woody debris from along the banks of the Waimata River when the digger tipped over into the river.

1. You check the nature and stability of the ground and physical dimensions of a working bench before operating a digger.
2. Cabs of excavators have a glass hammer to break the glass in event of an emergency.
3. Seat belts are not used when excavating in or around water bodies.
4. Life vests are available in the cab of excavators working in or around water.
