Safety Alert

27 September 2024

Fuel trailer axle snaps

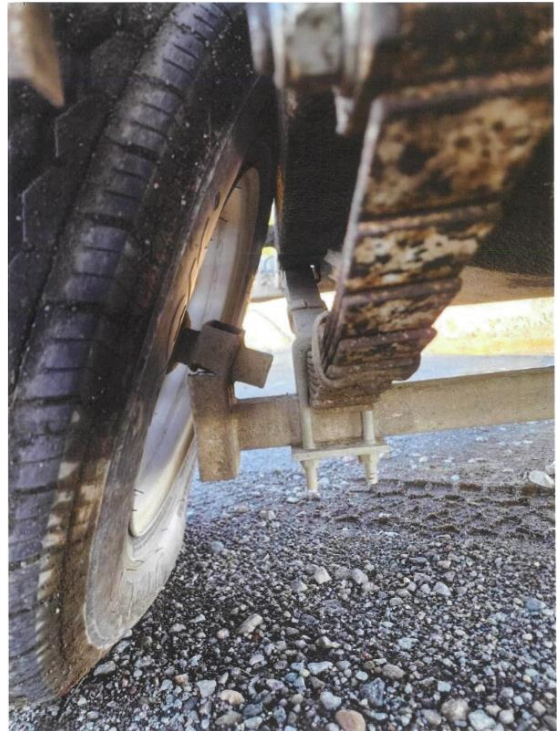
A worker was towing a fuel trailer behind a ute in a quarry when a wheel axle snapped. The ute was travelling at a relatively slow speed and was in an isolated work area.

There was no loss of load, spillage of fuel or additional damage to the trailer or ute.

If this had occurred while towing the trailer at speed or on a public road, this could have been a very significant incident.

1. Pre-start checks are conducted on all plant prior to being used.
2. All plant is serviced and maintained in accordance with the original equipment manufacturers recommendations.
3. Service intervals on plant that is not used regularly are adjusted to ensure plant is serviced regularly.
