Safety Alert

4 October 2024

Haul road damaged during storm

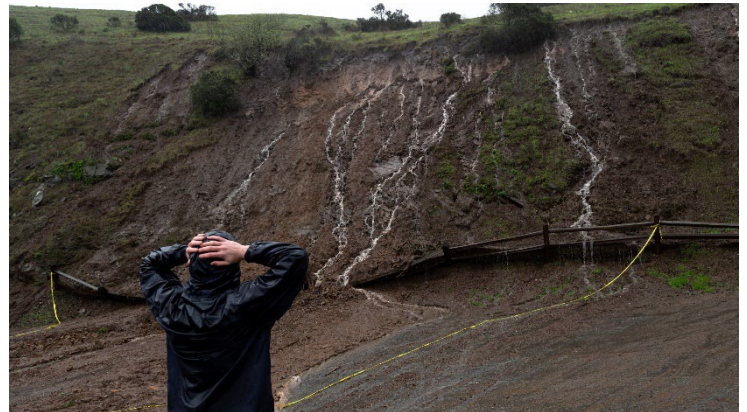
During a storm that dropped 112mm rain over a 24-hr period, culverts in the quarry could not handle the volume of water.

Storm water backed up and breached two meters of bunding, partially washing out the main haul road.

1. Inspection of the pit and haul roads is conducted before work recommences after severe weather events.
2. Culverts and drains are regularly inspected and cleared of build-up of material or blockages.
3. Haul roads are constructed of suitable material and are regularly maintained to ensure safe travel on them.
