Safety Alert

6 September 2024

Rockslide hits digger

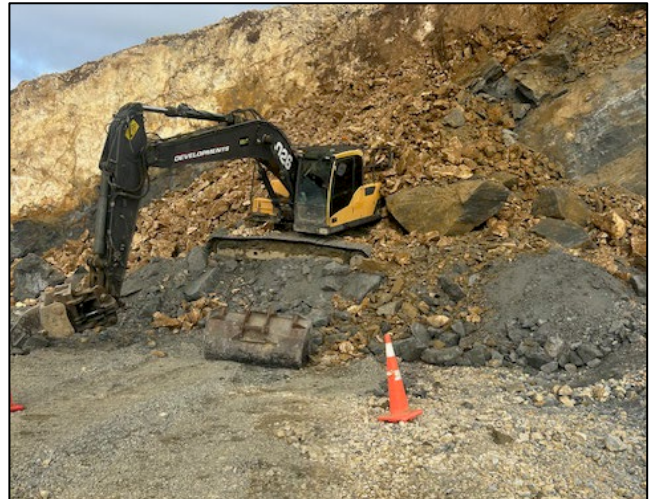
An operator was digging out the toe from the base of a face when rock fell, partially engulfing the digger.

The material rolled down a slippery back structure from the face sliding into and around the digger.

The worker was not injured in the incident.

1. You conduct a site assessment of geology and potential geotechnical issues to identify potential slope instability issues.
2. Regular site inspections for ground instability are conducted, particularly after significant rainfall.
3. A catch bench is established between the excavator and face when working at the face.
4. When operating an excavator at a face, ensure that the cab of the excavator is on the free side of the shot i.e. not facing the bench.
