WORKSAFE

Dump truck runs over back of mechanics light vehicle

15 December 2021

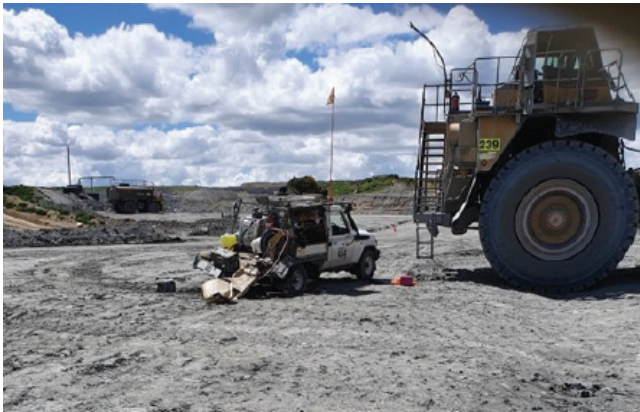
The mechanic parked in front and slightly adjacent of the truck to be serviced (shown in photo) and began work on the truck.

After completing the break, the driver of the adjacent truck, tooted the horn, started-up his truck, then tooted twice and drove forward. The operator turned right as can be seen by the wheel marks behind the LV. The rear truck tyre drove over the rear of the LV.

LV with crushed rear tray beside the CAT 789 dump truck

The truck driver was unaware that an incident had occurred and had driven approximately 500m before been notified on the RT. This truck can be seen in the photo (just above the LV) where it stopped.

Servicing of trucks in a truck park is a high-risk task. To reduce the risks the hierarchy of controls should be used.

- Servicing trucks in a separate area adjacent from other parked trucks.
- Windrow the separate service area. A windrow for the truck to separate it from other vehicles. Another windrow for the LV separating it from the vehicle being serviced and from other vehicles.
- If the truck cannot be moved to the separate service area. Conduct a risk assessment to determine a safe way to service the vehicle. The risk controls may include removing all other vehicles from the truck park before servicing the truck. Constructing a temporary windrowed area.
- Use windrowed truck parking that allows for separation between adjacent trucks. These windrows being long enough for the LV to park also in the windrowed area.
