NZ Safety Alert

9 December 2022

Ground failure incident

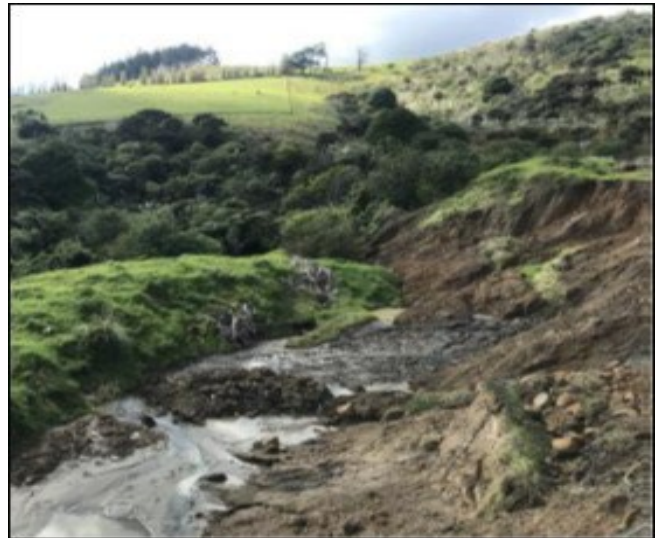
A water recycling detention pond used for water suppression and aggregate cleaning, had been drained.

Following heavy rainfall, a block of land/material approximately 15m across x 6m wide and a depth up to 10m has slid down the bank into a gully. No one was injured.

An inspection the day before indicated no structural failures, damage or instability in the surrounding ground.

Structural repair has been carried out to restore water detention and resume operations.

1. Regular site inspections for ground instability are conducted, particularly after significant rainfall.
2. There is adequate drainage to prevent water build up on or in unstable ground.
3. Hazards associated with all ground instability are identified in risk assessments, and adequate and effective controls are in place to ensure no-one is exposed to the hazards identified.
