WEEKLY INCIDENT SUMMARY

Week ending Friday 17 April 2020

Mine safety reference ISR20-16

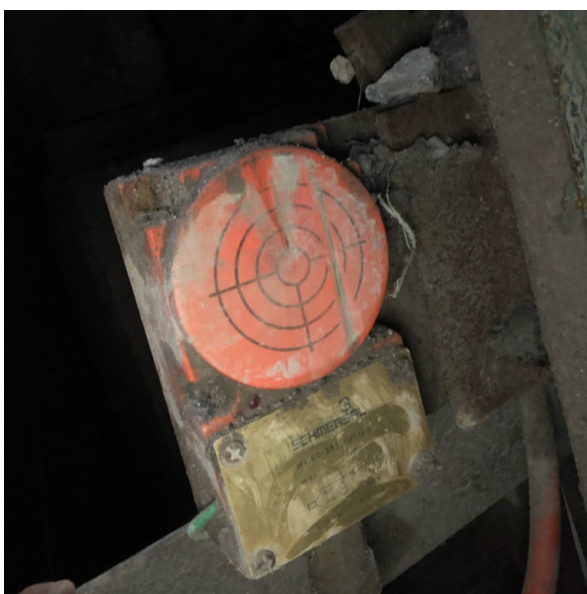
Dangerous
Incident
IncNot0037185
Underground
metals mine

A mill operator suffered an electric shock when opening a door at a surface crusher building. He made contact with the door's proximity switch and suffered an electric shock to his left hand.

A preliminary investigation suggests a diminished ingress protection (IP) rating of the proximity switch, together with the fact the area was wet, allowed the operator to be shocked when he touched the switch.

Electrical equipment that has an IP rating is critical in wet areas and should be maintained as fit-for-purpose throughout its life cycle. Mines that have control voltages to field devices above extra low voltage (ELV) should review how they manage the risk of electric shock, including the modification of field control circuits to ELV.
