# WEEKLY INCIDENT SUMMARY

Week ending Friday 26 June 2020

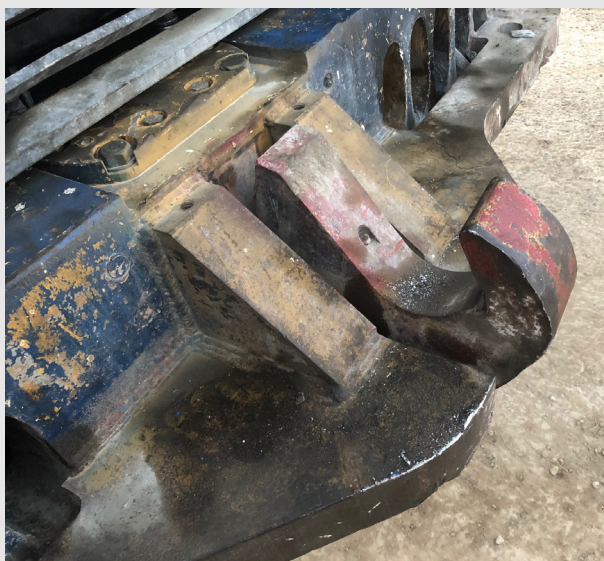
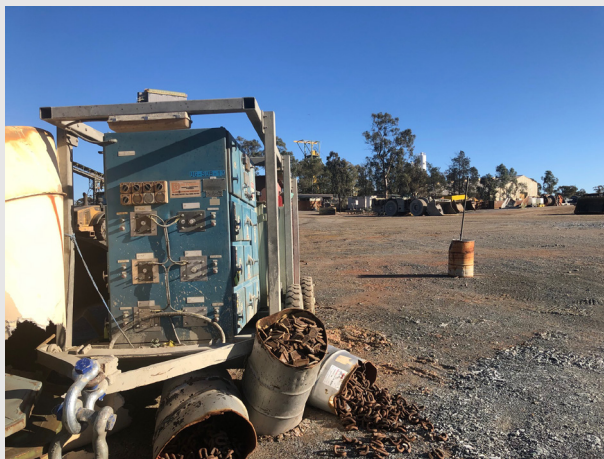
IncNot0037610

A loader was towing a skid-mounted sub-station that was fitted with temporary wheels.

The sub-station was being towed from underground to the surface.

After exiting the portal on the surface, the skid detached from the loader and rolled about 50 metres before striking a scrap steel area.

Mine operators should review their procedures to determine if their training includes the potential hazards associated with towing.

When connecting a trailer to a towing vehicle, ensure that the trailer is securely attached and held in position. Safety chains or similar should be attached between the trailer and the towing vehicle.

Driving at a low speed is not an adequate control when towing a trailer that is not securely attached to the towing vehicle.
