INCIDENT ALERT

LOCATION: AGGREGATE DREDGER
ACTIVITY: MAINTENANCE & HOUSEKEEPING
SUB ACTIVITY: N/A

ALERT STATUS: Normal
DATE ISSUED: 30/10/2020 11:16:10
INCIDENT No: 03573

Fatal 1 - BMAPA Alert - Stored energy/Stress in a damaged hull

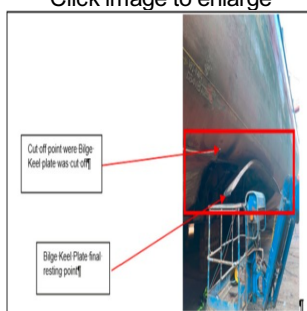
A contractor working in a UK ship repair yard was removing a section of damaged bilge keel by oxy acetylene burning. When reaching the end of his cut the stored energy / stress in the deformed bilge keel caused the plate to release downwards then upwards violently hitting the contractor on the chest, shoulder, jaw and head.

Fortunately, this did not end up with any life changing major injuries but it could have and it was completely avoidable if a task specific risk assessment had been completed.

- All tasks in a repair yard should be fully risk assessed to identify all risks present and not presume or assume personnel (including contractors/sub-contractors) understand all risks associated with tasks.

- Personnel are required to sign off the risk assessment for the task to confirm they have read and understood.
- Repair yards to ensure they have risk assessments in place for "Removing Material under stored energy"

- One-to-one briefing of workers by supervisor or manager to ensure they understand the method statement and associated risk controls.
- Any potential stored energy release tasks must be classed as high risk

- Specific control points are to be put in place to remove damaged hull plating in small sections with all plating / frames under stress marked up with cut lines / cut sequence

- Any plate being removed must be supported / restrained to control any release of stored energy
- Daily project meetings must ensure all high-risk activities are discussed and all associated work is properly planned.
