WEEKLY INCIDENT SUMMARY

Week ending Friday 24 January 2020

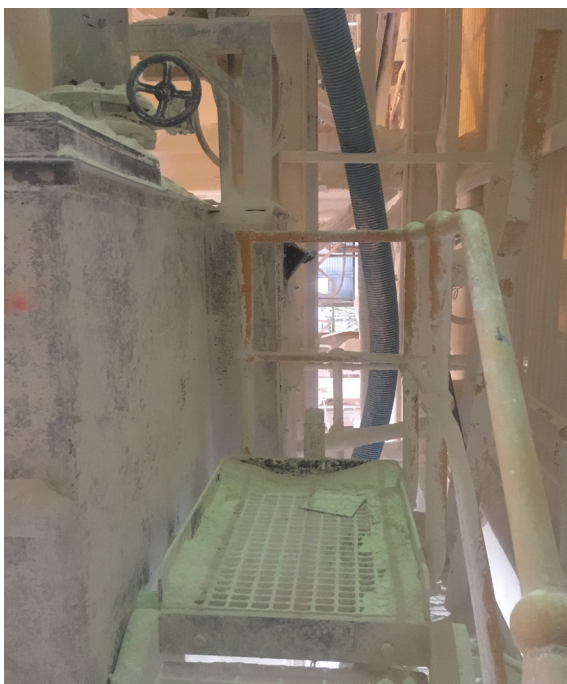
INCIDENT TYPE	SUMMARY	RECOMMENDATIONS TO INDUSTRY
Serious injury IncNot0036563 Mine processing plant	<p>A worker was cleaning within a lime hydration plant when he ingested hydrated lime. The mine's early investigation found that the worker caused hydrated lime to become airborne and he inhaled the substance.</p> <p>The worker was taken to hospital, where it was confirmed he had suffered a corrosive throat injury.</p>	<p>Mine operators are reminded that they must provide and maintain safe systems of work.</p> <p>Workers are reminded that correct personal protection equipment (PPE) must be worn in areas designated by the mine operator. Respiratory protective equipment is the last line of defence in the control of airborne dust inhalation.</p>

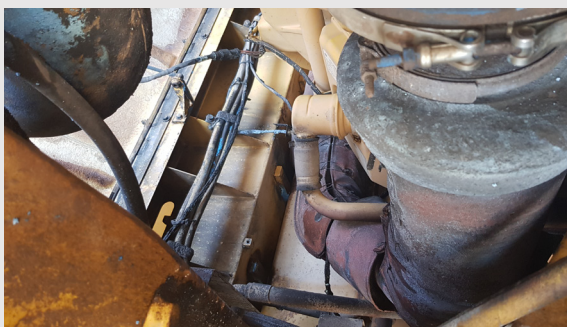
Dangerous incident
IncNot0036553
Quarry

A dump truck operator smelled fuel during mining operations. The operator drove the truck to where a maintenance fitter was located, before parking the machine. The fitter saw smoke and attempted to put the fire out with an extinguisher. A water cart attended and extinguished the fire.

A mine investigation identified there was fuel near the turbo, and a fuel line was damaged. It was also identified that there was no fire suppression system fitted to the truck.

Mine operators must remind machine operators that they are to stop and call for assistance when they identify any abnormal conditions such as smelling fuel or smoke.

Fires on mobile plant are a known risk to workers and this risk is preventable.

MDG 15 recommends that designers, manufacturers, importers and suppliers should undertake an assessment of all fire risks.

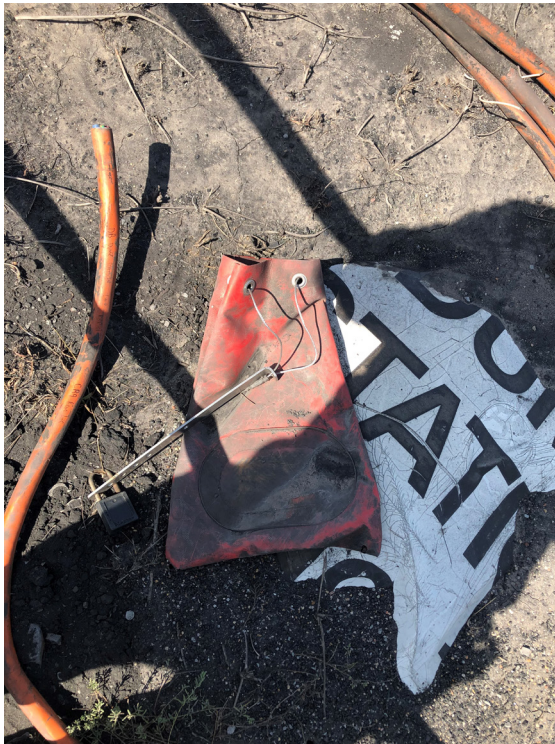
Dangerous incident
IncNot0036555
Coal preparation plant

An electrician was in the process of replacing a faded out-of-service tag on a disconnected 415-volt lighting cable when he suffered an electric shock. The electrician was treated following the mine's site protocol.

The mine investigation identified that the circuit was still energised and had not been correctly isolated at the supply source.

Coal operators should review the adequacy and reliability of the risk controls that are implemented at their sites to prevent electric shocks.

Electricians are reminded to prove that the circuit is dead before making any contact with it.

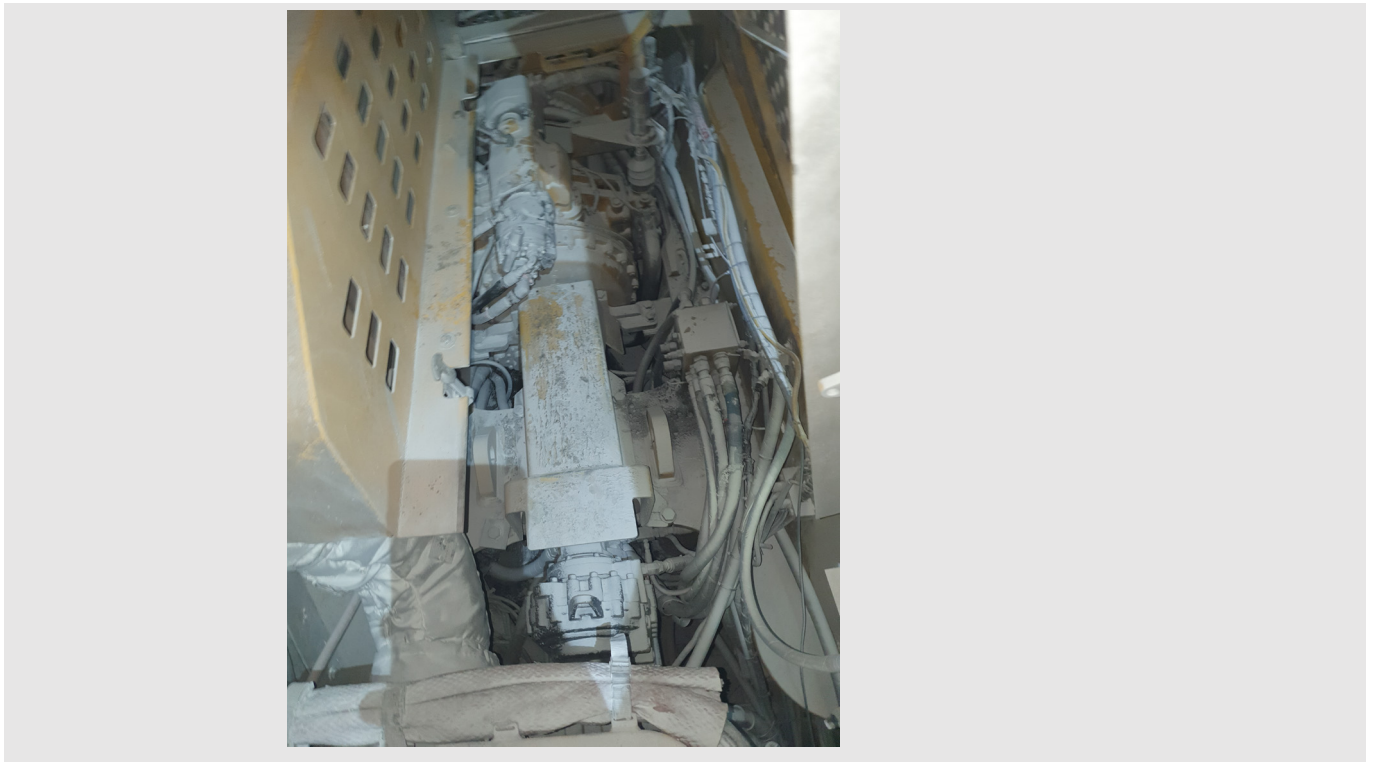
Dangerous incident
IncNot0036558
Underground metalliferous mine

During mining operations, a haul truck operator saw smoke, and then flames. He parked the truck and activated the fire suppression system. With the help of another two workers, they extinguished the fire with hand-held extinguishers. The fire was in the engine bay and articulation point of the truck.

The mine investigation identified the cause of the fire as a failure of a driveline bearing. The truck had recently returned from a transmission rebuild.

Following maintenance and repairs to mobile plant, the plant should be inspected, tested and verified as fit-for-purpose.

Mobile plant should have suitable maintenance schedules that take into consideration condition and hours of operation.
