Resources Safety and Health Newsflash

Metal shard projectile from excavator track sprocket

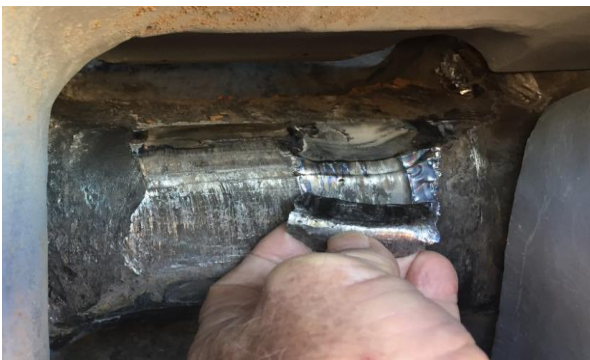
Figure 1

Following an undercarriage track change on an excavator, a metal shard (refer Figure 1) was ejected from the track sprocket. The metal shard travelled 35 meters (refer Figure 2) breaking a side window and entering the cabin of a parked service truck.

In this incident, the metal shard ejected in line with the track frame; however, metal shards may be ejected at any angle from the tracks. Whilst no injuries were reported on this occasion, coal mine workers have suffered serious injuries from flying metal shards in cases reported to the Mines Inspectorate. The track sprocket was a refurbished sprocket and not an original OEM sprocket.

- Ensure that OEMs or service providers provide all replacement components that are fit for purpose. This includes confirmation and documentation of component refurbishment processes, quality control checks and engineering certification of components including tracks sprockets and idlers.
- Review risk assessments for track maintenance and consider enforcing a 360-degree exclusion zone around excavators when track maintenance is in progress. In particular, consider the radius of the exclusion zone.
- Ensure that suitable ballistic protective equipment is available to spotters required by maintenance procedures.
- Consult with the OEMs or service providers to ensure that the correct track maintenance procedures are available.
