SAFETY ALERT

INCIDENT	A1 – P4 Crane Incident
SUBJECT	Crane outrigger footing not confirmed
INCIDENT DATE	24-09-2020
BUSINESS UNIT	FCI – Puhoi to Warkworth Project

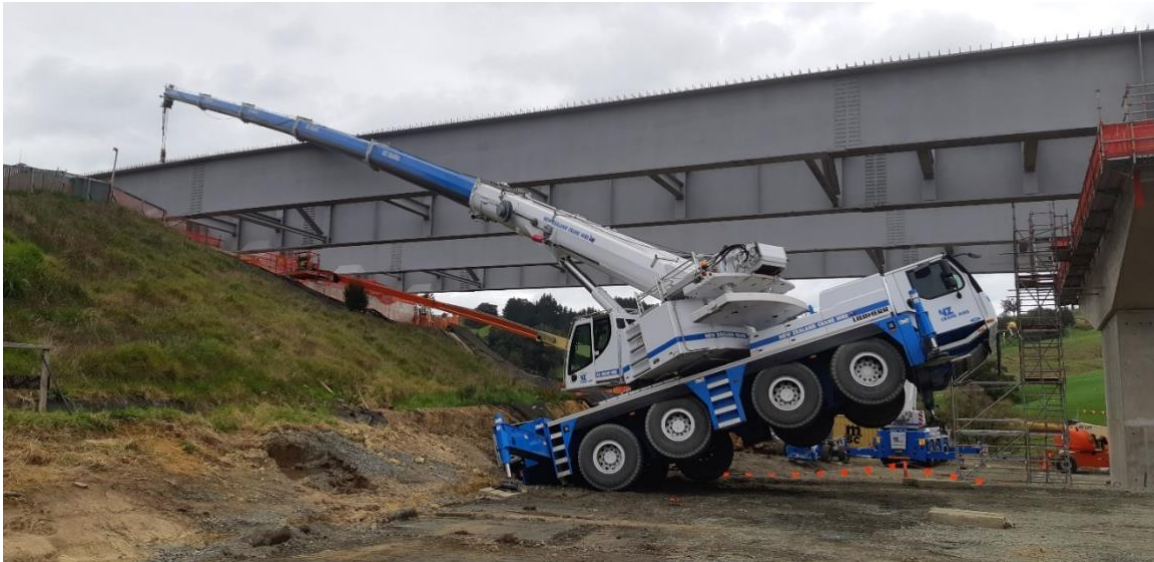
During lifting activities at the Puhoi Bridge a 90 Tonne Cranes rear outriggers have sunk resulting in the crane tipping and the boom hitting the bridge beam. The crane was lifting approximately 150kg.

The operator stayed in the crane until he had an opportunity to get out safely. No personnel were injured.

The site was made safe and supervisor notified. An investigation team is being mobilised and a recovery plan for the crane is being developed. Initial investigations have determined the crane was set-up on a non-approved work platform

- A Permit to Load must be in place for the set-up and use of all cranes and associated equipment with outriggers
- ALWAYS check the stability of the ground prior to setting up the crane
- If something changes during an operation always ensure that the risks are reassessed before commencing task.
- NEVER set up a crane to lift without first confirming the location of the outriggers.
- ALWAYS have an authorised lift plan in place prior to commencing the lift.
