WEEKLY INCIDENT SUMMARY

Week ending Friday 10 January 2020

This incident summary provides information on reportable incidents and safety advice for the NSW mining industry. To report an incident to the NSW Resources Regulator: phone 1300 814 609 24 hours a day, 7 days a week.

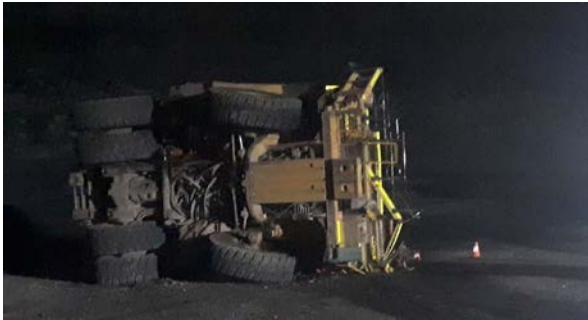
Dangerous incident
IncNot0036443

INCIDENT TYPE	SUMMARY	RECOMMENDATIONS TO INDUSTRY
Dangerous incident IncNot0036444	<p>A CAT 775D service truck was descending a ramp at a surface coal mine that was recently watered. The truck began to slide for about 50 metres, then gripped on the dry line of the ramp, resulting in the truck overturning on to the driver's side. The operator was not injured.</p>

<p>All personnel who operate rubber-tyred, heavy mining equipment should be trained on driving techniques in wet conditions.</p> <p>Management plans and procedures should identify ramp and cresting speed limits.</p> <p>The recommendations from <u>Safety Bulletin SB18-09 - Overwatering of roads leads to vehicle incidents</u> should be reviewed and fully implemented.</p>

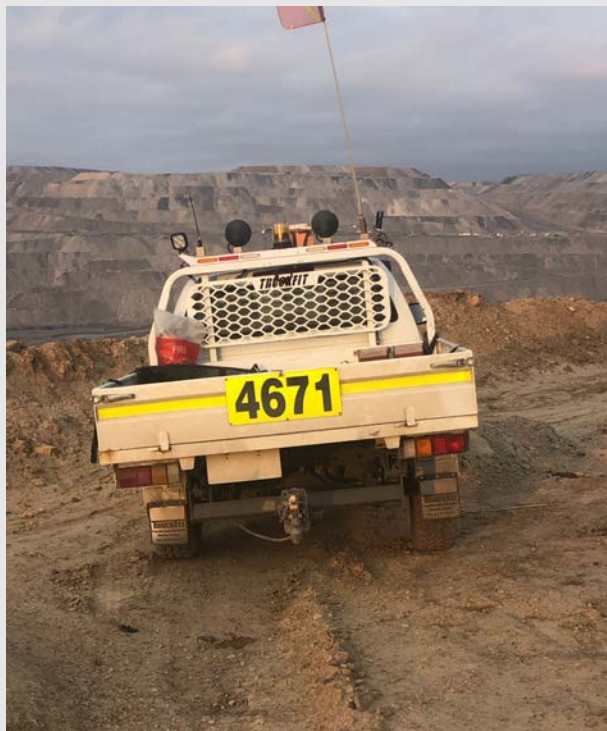
At a surface coal mine, a drill operator driving a light vehicle stopped and got out to talk to an operator in another light vehicle. The drill operator's vehicle started to roll away and he attempted to open the door to get back in. The operator became caught between the two vehicles and was spun three times between the trays. The vehicle rolled about 50 metres, over a bund and down a 4-metre slope and continued another 15 metres before stopping.

The operator reported he was distracted at the time and could not recall applying the park brake before getting out of the vehicle.

Although the operator was not seriously injured, he suffered some scratches on his back from hitting the trays and was fortunate to have not suffered more serious injuries.

Management plans and vehicle operating procedures invariably specify a requirement for vehicles to be parked fundamentally stable.

The circumstances of this incident highlights why this is so, and why mine operators should continually reinforce the importance of complying with safe work procedures.

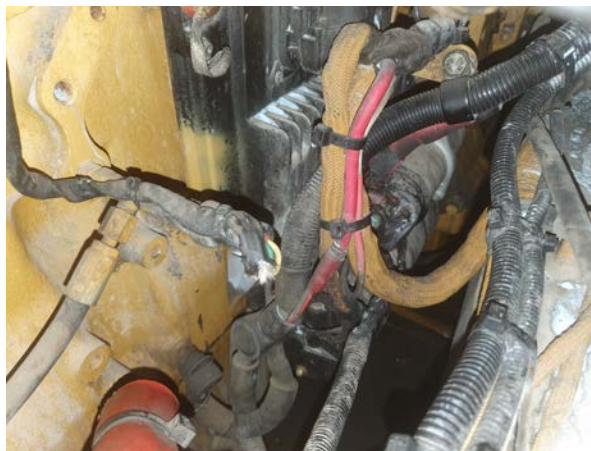
Dangerous incident
IncNot0036461

A fire occurred on a loaded concrete agitator at an underground metalliferous mine. The operator had set up to spray cement in the decline when he saw a fire at the front of the agitator.

The cause of the fire was determined to be water ingress into the starter motor. Previous modifications allowed water (which is regularly used to clean the machine) to get into the engine bay and subsequently the starter motor.

The fire was extinguished by the onboard fire suppression system and a hand-held extinguisher.

required. In this case, modification of the engine covers (to address another risk) allowed excessive water into the engine bay.

When modifying equipment, mine operators must conduct adequate change management to ensure any new risks are identified and additional controls are implemented as
