INCIDENT ALERT

LOCATION:	AGGREGATE DREDGER	ALERT STATUS:	Normal
ACTIVITY:	MARINE OPERATIONS	DATE ISSUED:	17/06/2020 16:49:12
SUB ACTIVITY:	DREDGING	INCIDENT No:	02564

Finger dislocation on induction tour - BMAPA alert

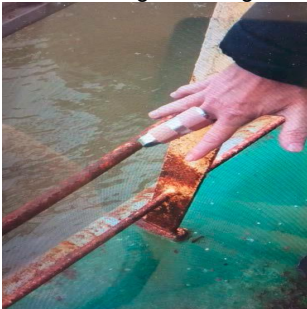
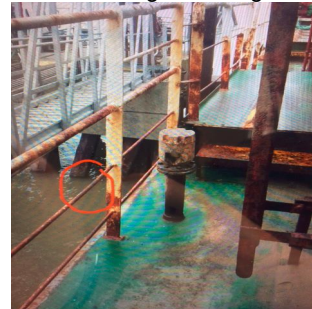
During this walk around the IP lost his footing on a rogue stone on the safety walkway put out his hand to steady himself and caught his finger on the middle safety railing causing it to bend back and dislocate.

Vessels to conduct a Safety Briefing discussing the above incident highlighting the importance of conducting a good briefing with new unfamiliar crew members before conducting a tour of the vessel, reminding of the importance of being vigilant when conducting routine activities.
