WEEKLY INCIDENT SUMMARY

Week ending Friday 15 May 2020

This incident summary provides information on reportable incidents and safety advice for the NSW mining industry. To report an incident to the NSW Resources Regulator: phone 1300 814 609 24 hours a day, 7 days a week.

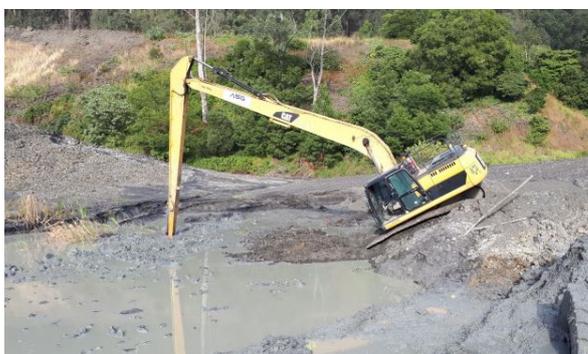
IncNot0037359

An operator was digging out a sediment pit with a long-reach digger when the ground at the front of the digger gave way and the digger tipped forward about 45 degrees.

The operator lowered the bucket to stabilise the digger and exited the machine.

The excavator was working from a constructed bench to remove sediment and load it into a haul truck.

Equipment operators must maintain situational awareness and remain vigilant to the risk of machine rollovers.

Suitable bunding should be in place to protect mobile plant from accessing edges of benches. If bunding is not installed, there should be adequate demarcation of the work area, so operators are aware of their positioning in relation to the bench edge.
