NZ Safety Alert

29 October 2021

Rockfall damages crusher

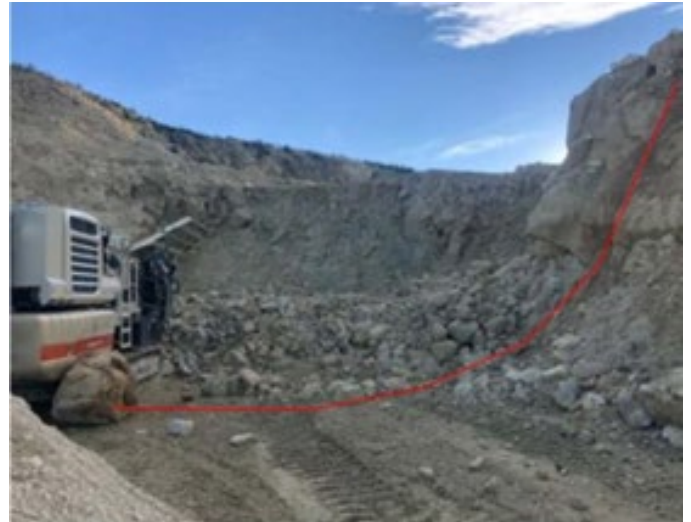
Over the course of a weekend, a rock dislodged from a quarry face, rolled down the face and hit a mobile crusher in the pit.

Heavy rain and a minor earthquake occurred over the weekend; however, the catch bund had been removed and scaling of the face had not been completed.

No-one was present at the site, and the crusher sustained minor damage.

1. You regularly inspect high risk faces with the potential for rockfalls and install adequate catch bunds or other controls to protect workers from potential rockfalls.
2. You install adequate bunding or trenching between mobile plant and the face while working near or at the face.
3. All workers are aware of the risks of rockfall and the controls necessary to protect them from exposure to rockfalls.
