# WEEKLY INCIDENT SUMMARY

Week ending Friday 17 January 2020

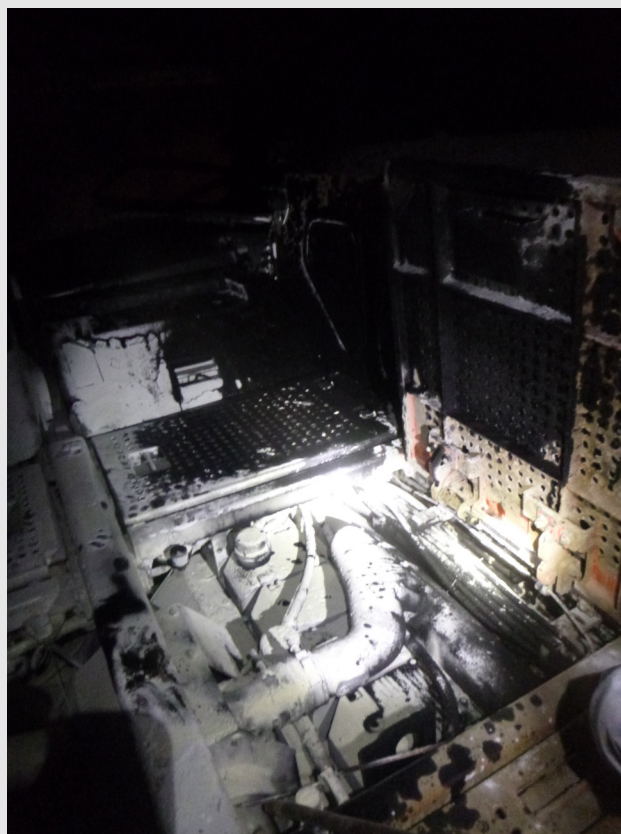
Dangerous incident  
IncNot0036464  
Underground  
metalliferous mine

A haul truck caught fire while travelling up a decline.

The cause of the fire was an internal failure in a recently rebuilt engine. A mine investigation identified the tappet cover breather caps were modified from a metal cap that was held in place with a circlip, to a plastic cap held with silastic. This allowed the over-pressured engine oil to make contact with the hot engine.

The original equipment manufacturer (OEM) is investigating the engine failure.

When equipment modifications occur, mine operators must confirm that adequate change management processes are followed. This will ensure that any new risks are identified, and additional controls are implemented to reduce the risk to plant, equipment and workers.

Engine breather caps should be checked and confirmed to be suitable, as specified by the OEM.

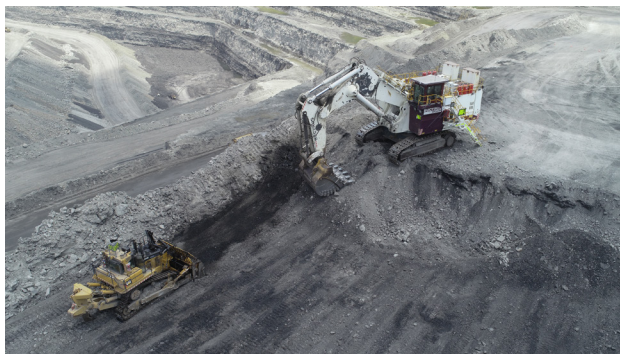
Dangerous incident  
IncNot0036471  
Surface coal mine

An excavator was loading overburden. The first bucket was taken from an out-sequence location. When the excavator swung back to the face it hit a dozer lift ram.

The dozer was cleaning up the dig floor and the operator had assumed that the excavator would not return to the same location.

The mine is implementing proximity awareness technology that is being commissioned.

Mine operators should remind all equipment operators of the importance of positive communication across all parts of the mine site.

Dozer operators should make positive communications with excavators before entering any excavator swing radius.

Mine operators should consider proximity awareness technologies for high interaction areas.

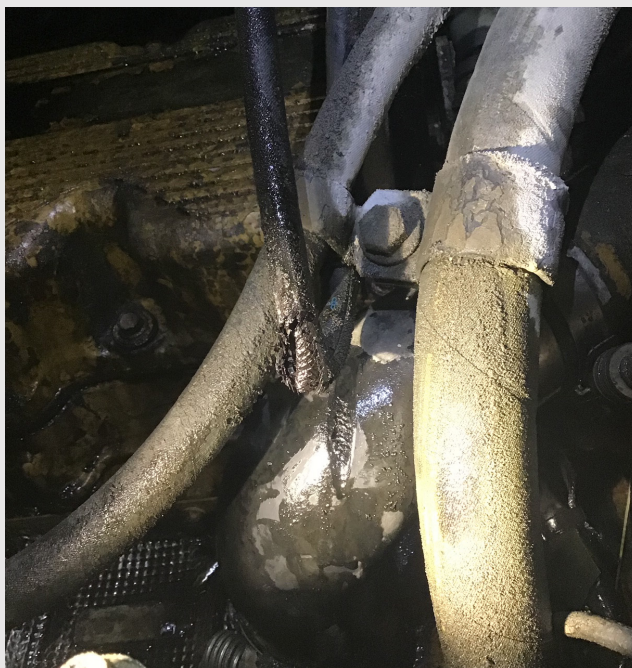
Dangerous incident  
IncNot0036500  
Underground  
metalliferous mine

An underground loader was in a draw point of an extraction drive.

The operator saw smoke coming from the engine area. The operator shutdown the loader. He inspected the engine bay and saw flames coming from the belly plate area. He activated the fire suppression system, which extinguished the fire.

A mine investigation identified that the mine had made a modification to all its loaders to facilitate taking engine oil samples. The failed hose had been clamped in place and was not part of any scheduled service inspection.

The OEM did not approve any modification.

When modifications take place, mine operators should challenge if the modifications are the best option. Consultation with the OEM is suggested when the modification is identified as a life of asset modification. Operators must confirm that adequate change management processes are followed to ensure any new risks are identified and additional controls are implemented.

Any modifications to plant must be added to service schedules so that they are maintained throughout the life of the asset.

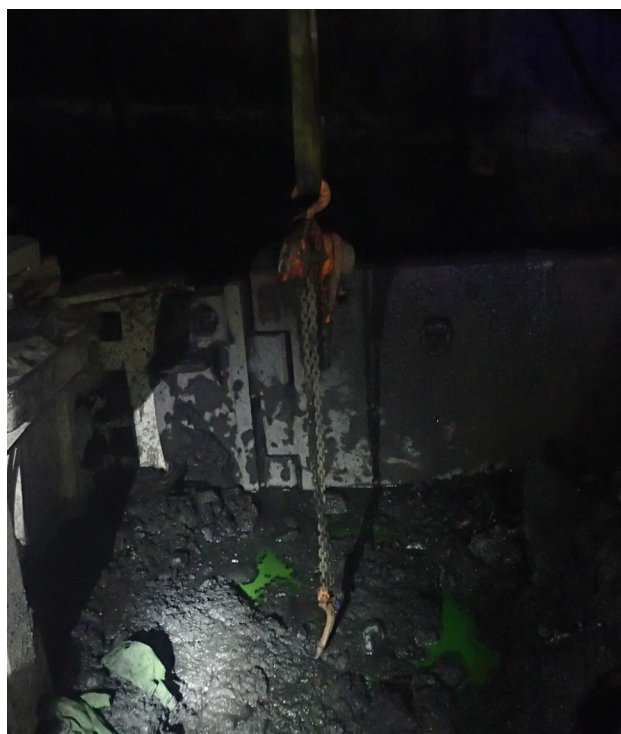
Serious injury  
IncNot0036504  
Underground coal  
mine

During production on a longwall face, a roof support relay bar became disconnected from the tailgate drive frame because of the failure of the vertical connecting pin.

A mechanical fitter was trying to realign the relay bar clevis by lifting the relay bar with a chain block. The security of the attachment point between the chain block and the relay bar was not verified because the hook was underwater.

The relay bar was then operated by manual hydraulic control in order to realign the vertical pinhole. This caused an additional load on the chain block hook. The hook became disconnected from the relay bar and hit the mechanical fitter's face.

The fitter suffered lacerations and minor fractures to his right cheekbone.

A mine investigation identified there was no safe work procedures (SWP) in place for this task.

Mine operators should review their lifting equipment management plans to ensure all tasks using lifting equipment have appropriate SWPs developed for routine and non-routine tasks.

Mine operators must provide adequate information, training and instructions to protect workers from risks while carrying out lifting tasks.

When repairs and maintenance are being carried out, safe standing zones must be established to account for any failures.

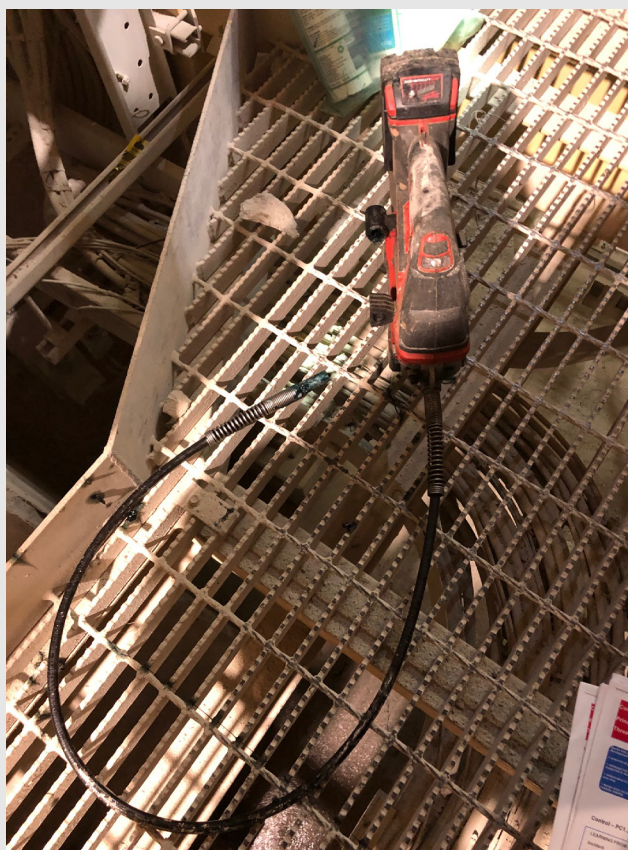
Dangerous incident  
IncNot0036508  
Underground  
metalliferous mine

A fitter was attending to a breakdown at an underground plate feeder. He was using a battery-powered grease gun to purge grease lines. When he disconnected the grease gun from the grease nipple there was a high-pressure release from the grease nipple that hit him in his forearm.

The fitter was taken to hospital where it was confirmed that he had suffered a fluid injection injury. The fitter underwent surgery to remove the grease.

The mine removed all the battery grease guns from service until its investigation was completed.

Ensure all employees working with or around equipment with high-pressure hydraulic systems are fully aware of the dangers of fluid injections entering the body and the damage they can cause. Mine operators should develop emergency response procedures for dealing with high-pressure fluid injection.

Pressurised fluid injuries are a failure of a risk control to a major hazard. When equipment is tested or repaired, no standing zones must be implemented to remove workers from the line of fire if a failure occurs.
