NZ Safety Alert

31 July 2020

Drill rods fall from underground strata

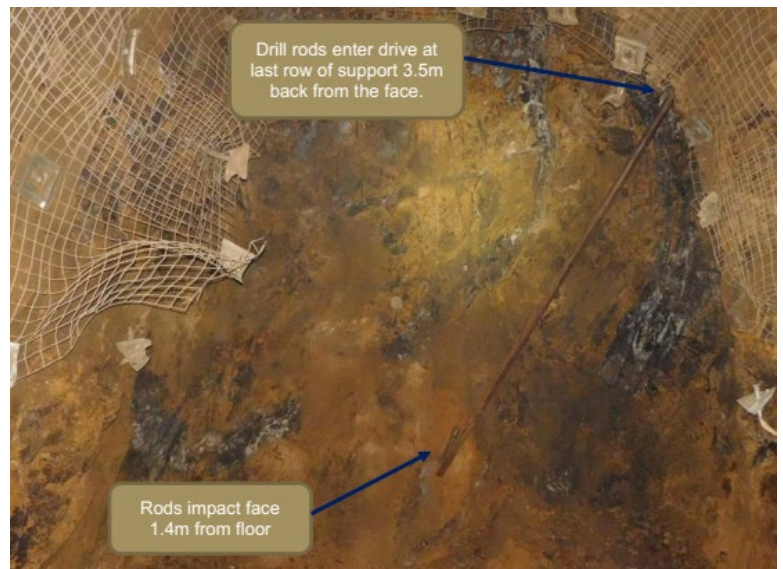
A loader was reversing from the face in an underground operation when diamond drill rods dropped rapidly from the last row of ground support (3.5m from face) and struck the face.

Two years earlier an exploration hole was diamond drilled from the surface to the depth of the proposed mining. Issues were encountered with ground conditions resulting in a number of drill rods being left in the hole.

The drill hole was marked on the development plan but there was no reference to it containing lost rods.

1. Development designs and plans include known voids or drill holes, grout, lost equipment, and any water intersections.
2. You review and update underground risk registers to ensure they address potential interaction with surface drill holes.
3. You document, implement and communicate the process for authorisation and effective control of abandoned drill rods in UG mining and tunneling operations.
