Incident alert

LOCATION:	AGGREGATE DREDGER	ALERT STATUS:	High Potential
ACTIVITY:	ACCESS & EGRESS & WORKING AT HEIGHT	DATE ISSUED:	13/01/2020 11:50:26
SUB ACTIVITY:	N/A	INCIDENT No:	01543

Fatal 6 - Working at height - high potential near hit

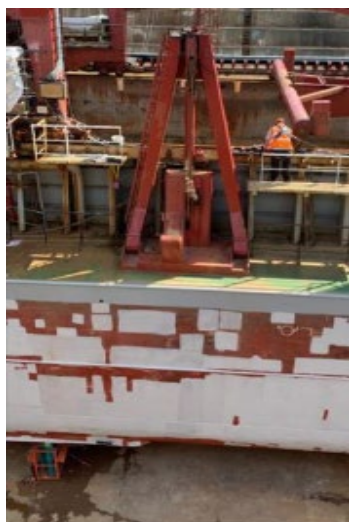
Image 'a'

The Contractor was only wearing a single tail work restraint lanyard (the RA had identified that two lanyards were required for the task). During the work activity the contractor was observed moving off the safety walkway onto the intermediate gantry without using the specified twin lanyards and without clipping his single lanyard to a securing point, thus exposing himself to a potential 10 metre fall (image 'a'). Once reaching the intermediate gantry, the single lanyard was then incorrectly attached to a vertical wire and not to a fixed point. In the event of a potential fall from this point, the lanyard would have slid down the length of the wire rather than arresting the fall (image 'b').
