NZ Safety Alert

7 February 2020

Water Cart hits service vehicle

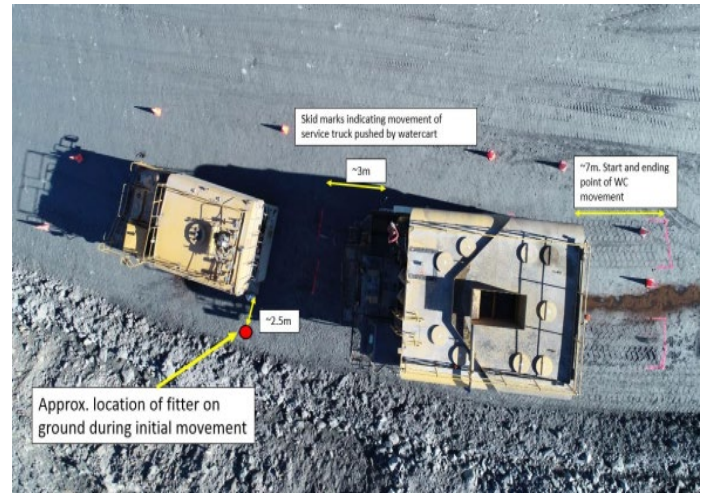
A water cart had broken down on a ramp and repairs had been completed on it. The service truck was positioned in front of the water cart.

The wheel chocks were removed from the water cart and the machine was started by the operator who was standing on the catwalk waiting for the service truck to move away.

The service truck operator was standing beside the service truck when the water cart started to move toward the vehicle.

The water cart travelled approximately 7 metres and made contact with the rear of the service truck, pushing it approximately 3 metres before stopping completely.

1. Vehicles are fundamentally stable when parked and/or being worked on.
2. Safe work procedures and risk assessments consider controls when working on vehicles parked on uneven surfaces or where there is potential for uncontrolled movement.
3. Unless involved in the specific task, all persons are well clear of mobile equipment when it is being moved or worked on for maintenance.
4. All mobile plant is maintained in accordance with Original Equipment Manufacturer requirements.
5. Workers are trained and assessed as competent to operate mobile equipment.
